# Detroit Lake Restoration and Enhancement Design Booklet

U.S. Forest Service  
Detroit Ranger District

October 7, 2011

Prepared by: Alex Misar and Lytton Reid

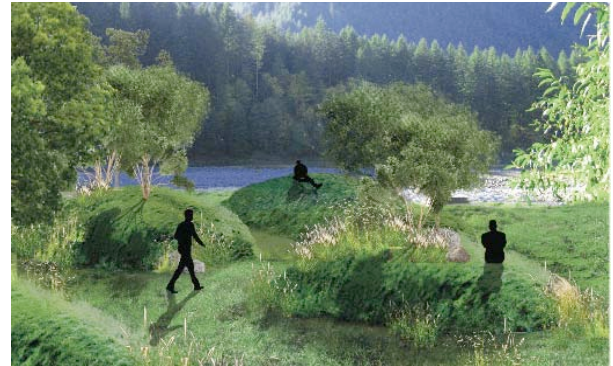
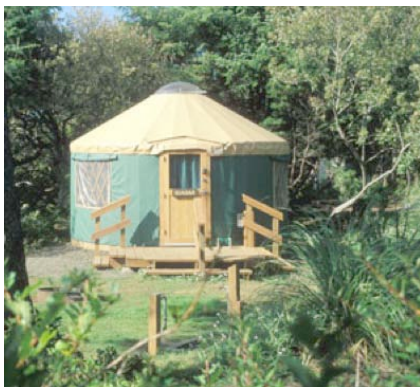
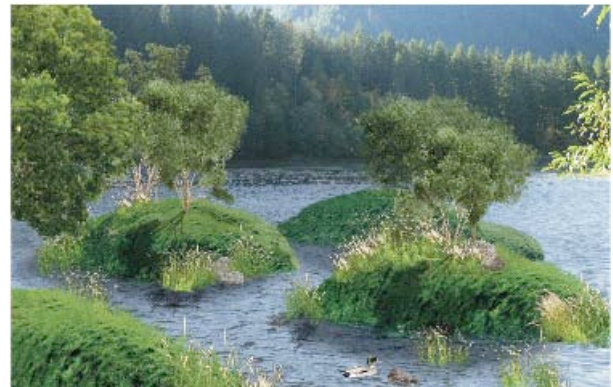
Audrey's design for Santiam Flats explored the creation of a more naturalistic camping experience. With better ties to the water and an improved ecological zone through the use of micro topographic islands, this design created a holistic place for humans and animals. The inclusion of covered shelters, boardwalk paths and yurts has significantly improved upon the status of the existing campground.

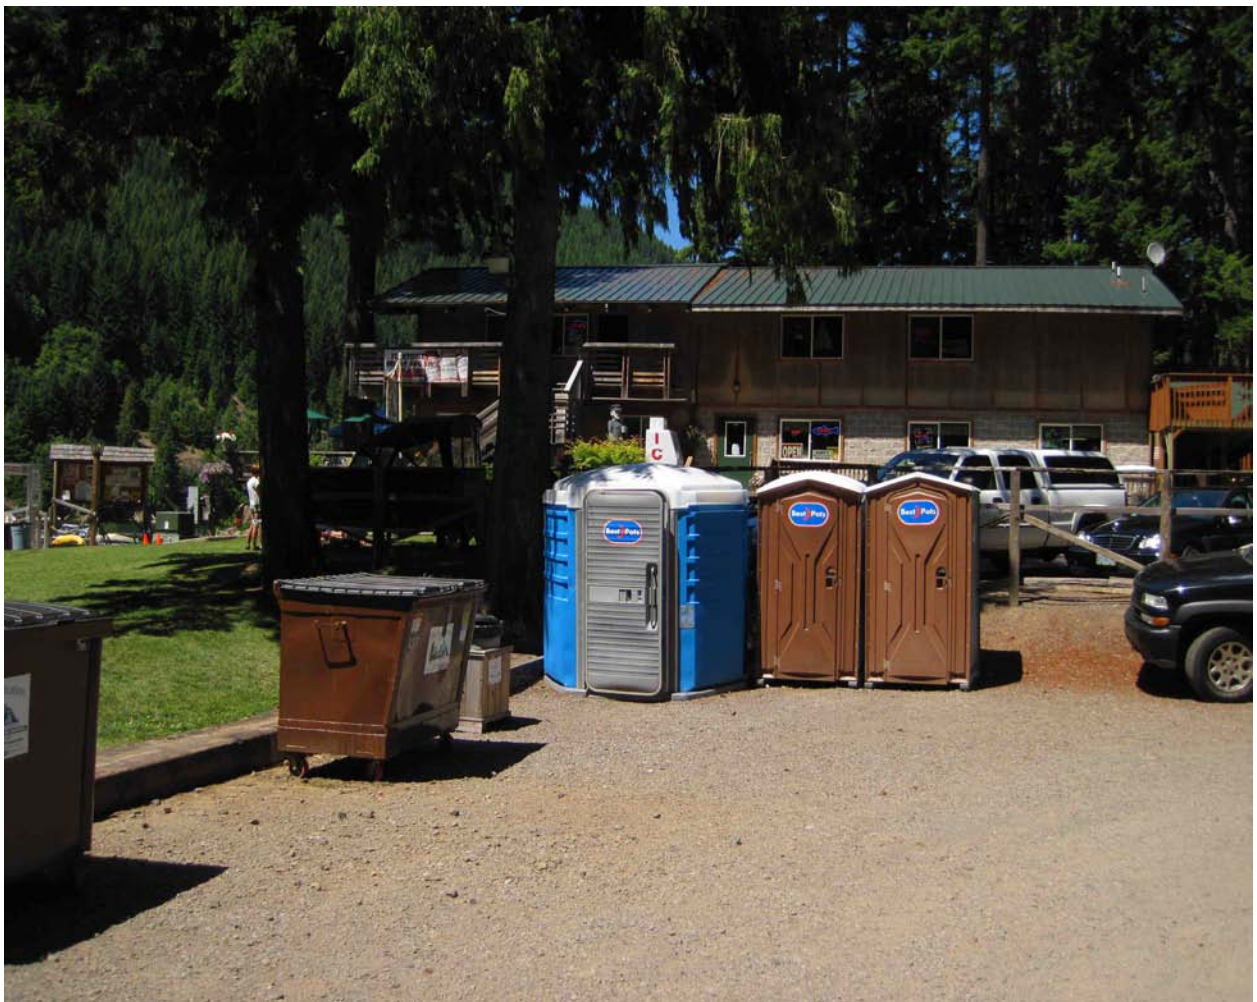
Fig. 6.5.1 - A; Kanes Marina Existing Rest Rooms

Facilities at Kanes Marina are limited in both number and quality. Serious improvements are needed to accommodate for both an increased number of users as well as to meet an improved landscape vernacular. Restrooms consist of a number of port-a-potties which are unsightly and are not imagable in any regard. Trash receptacles and on-site recycling are limited and hard to find and are often full or overflowing from excessive use. Seating consists only of picnic benches which are generally in high use.

The design recommends the installment of two new restroom facilities on-site to replace the current port-a-potties. CXT Cascadian vault toilets (currently used at Piety Island) are one option, however, another option could include connecting directly to the city of Detroit's municipal water system. These restrooms must have a 100 foot setback from the water and should sit above the 1569 foot contour.

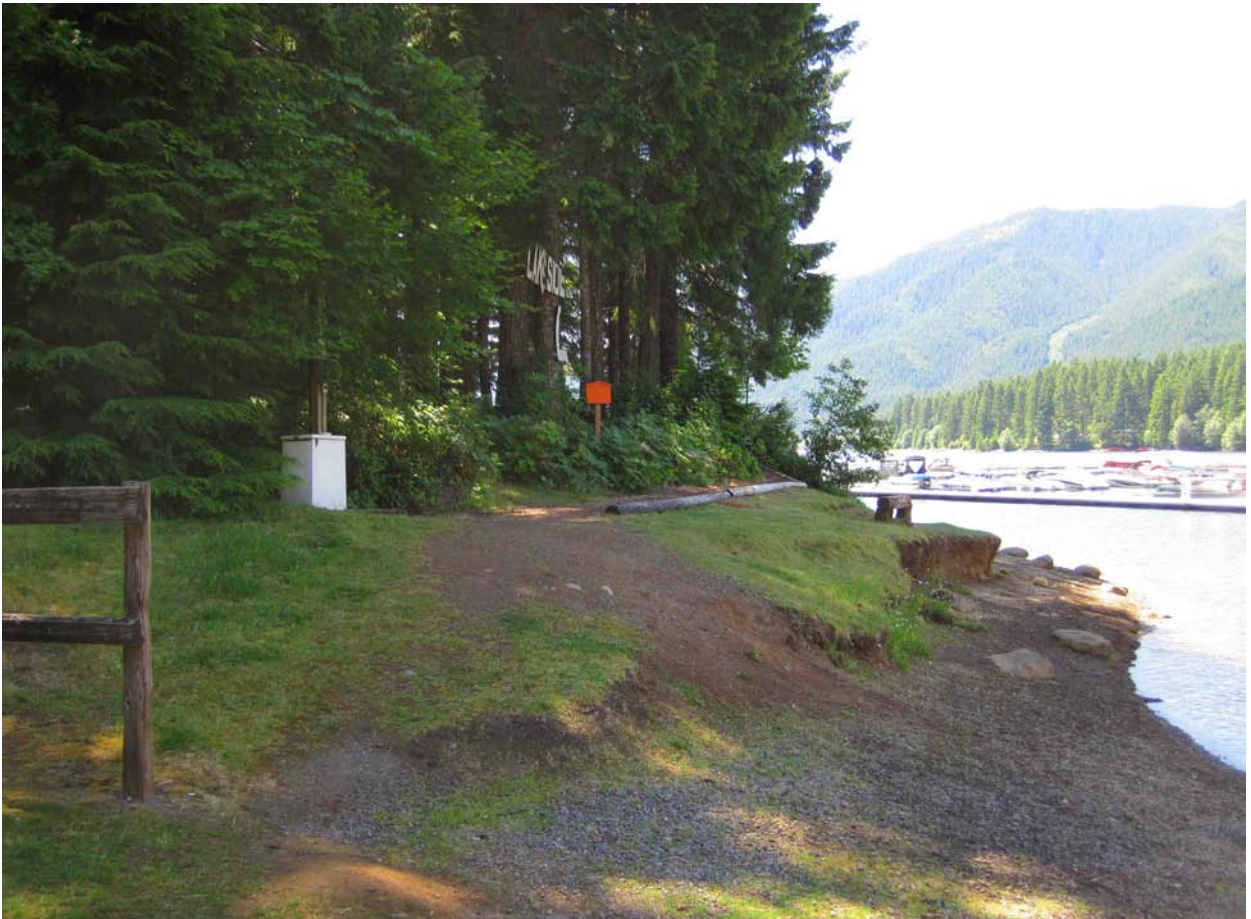
Fig. 6.5.2 - A; Kanes Marina Existing Trailhead

There is much room for improvement of this trail heads, including ADA accessibility, as it is currently inaccessible by individuals with physical disabilities.

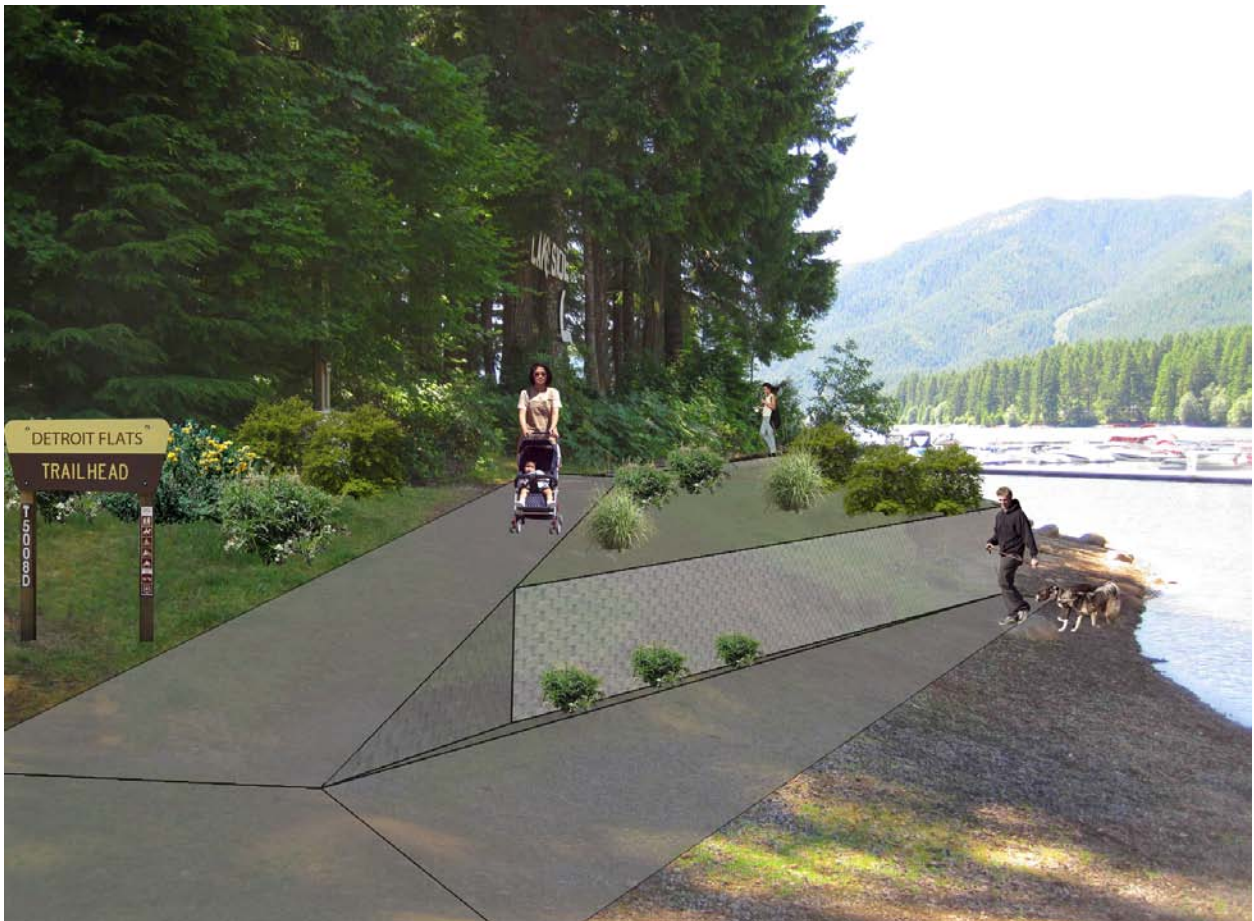
Fig. 6.5.3 - B; Kanes Marina Proposed Trailhead

A trail head sign and area map is recommended. Trail destinations, distances and walking times should be included in signage information.

Trash and recycling receptacles should be installed at or near the trail head to reduce litter on the trail and bring visitors awareness to maintenance efforts.

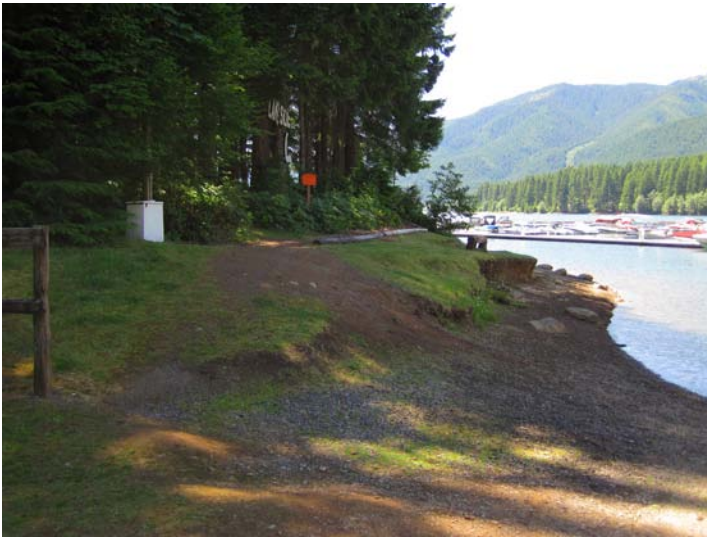
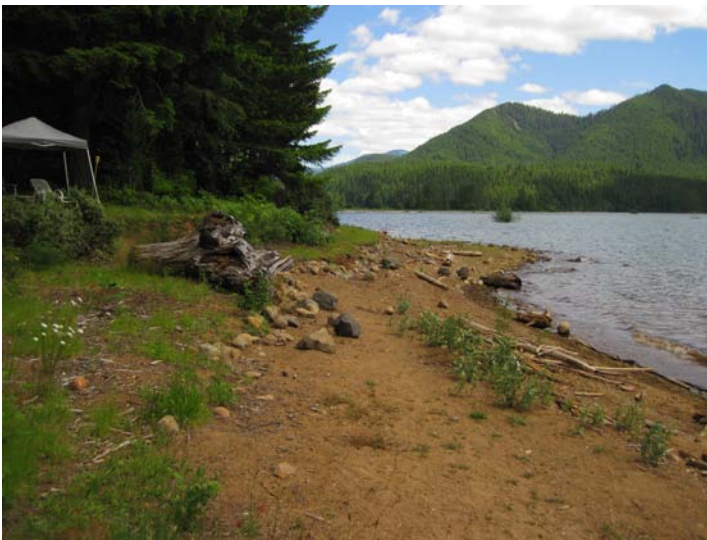
There is currently no continuous trail linking Kanes Marina and the Day Use Area at the Southeast end of Detroit Flats. A partial trail beginning at Kanes Marina follows the shoreline, then ends abruptly within a few hundred yards. The existing trail is rustic and does not accommodate visitors with physical disabilities, such as individuals in wheelchairs or those using walkers. There is currently no designated resting place along the trail, such as benches or covered areas.

Fig. 6.5.3 - A; Kanes Marina Existing Trailhead

Fig. 6.5.3 - B; Kanes Marina Existing Trail

There are different user groups that will need different types of paths, including paved paths, rustic campground paths, hiking and adventure trails. All trails within the Detroit Flats Area are to be clearly marked with trailhead signs and directional signs at intersections.

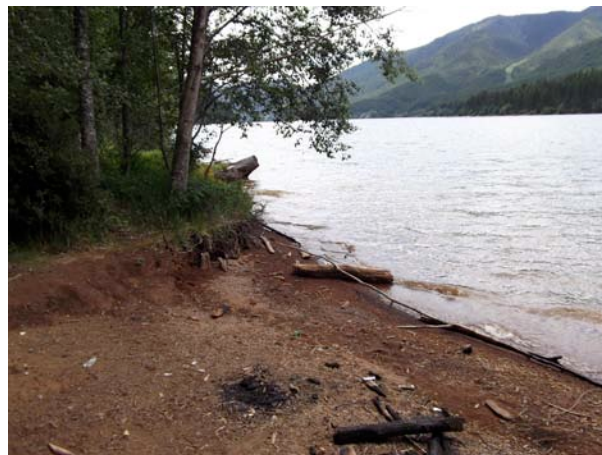
Fig. 6.5.3 - C; Kanes Marina Existing Trail

Kanes Marina has a number of areas where the existing path sits atop the eroded shoreline with a sizeable drop off the edge. New paths can be incorporated into the shoreline stabilization projects in certain areas, which would strengthen the design and increase safety in these areas.

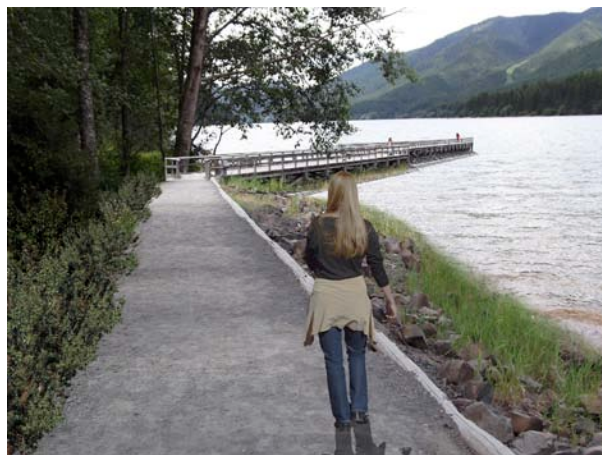
Fig. 6.5.3 - D; Kanes Marina Proposed Trail

The existing path, beginning at Kanes Marina will extend along the shoreline briefly. Along this section there are two proposed fishing piers. Beyond the fishing piers, the trail traverses a bridge and continues toward the Day Use Area along a series of islands.

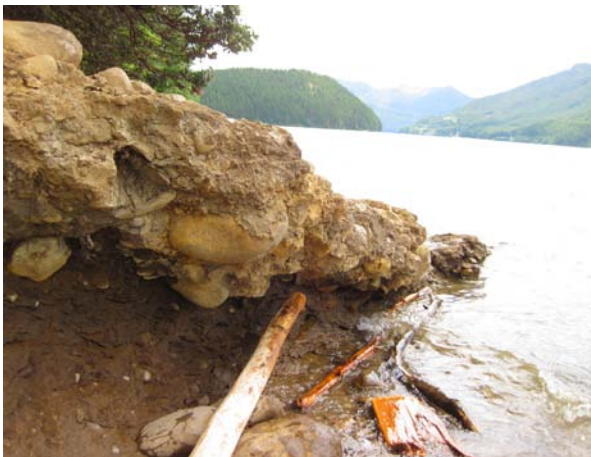
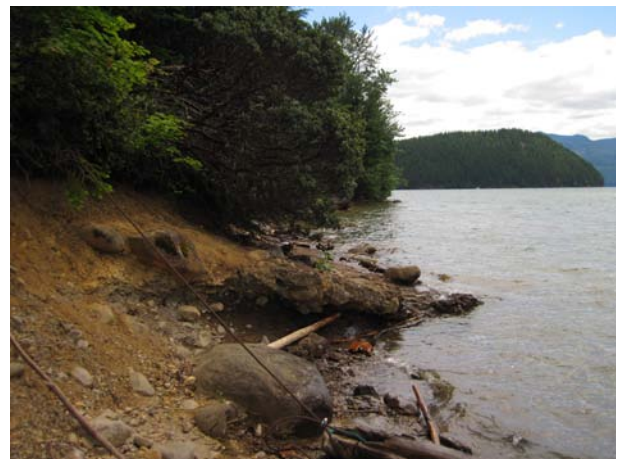
Fig. 6.5.4 - A,B; Kanes Marina Existing Shoreline

Erosion processes are a natural part of the hydrologic cycle and provide essential habitat for plants, fish and wildlife as well as ecosystem services such as water filtration and soil formation. Erosion of Detroit Lake's 32 miles of shoreline however is arguably unnatural, as it is a product of the man-made Detroit Dam, built in 1953 to control flooding.

Erosion is most extreme at elevations near the normal pool water level of 1,563 feet above sea level during the summer season when strong wind waves and boat wakes breakdown the softer sedimentary layers of the steep banks. For six months of the year, from mid-April until mid-September, the water level is typically between 1,554 feet and 1,566 feet (though levels could be as low as 1,542 feet during the popular boating season in years of drought). This section of the shoreline is in critical need of stabilization because it undergoes the most damage in a very short period of time (fig.6.5.4-A,B).

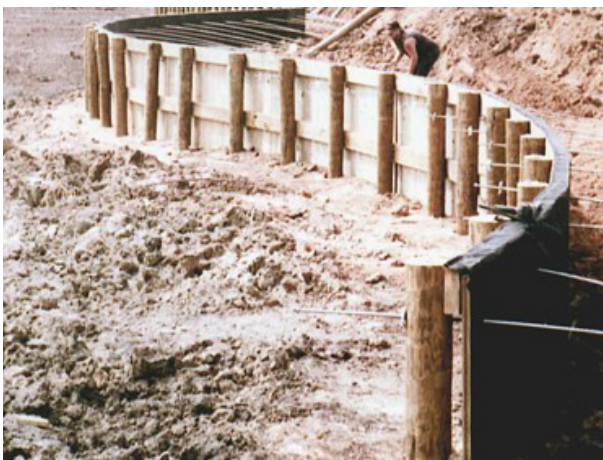
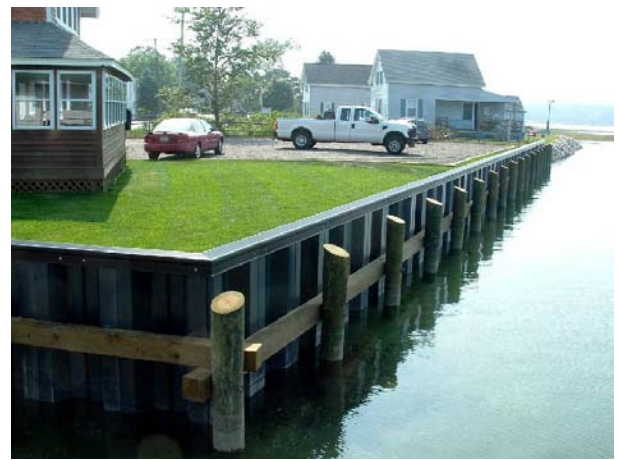
Fig. 6.5.4 - C-D; Kanes Marina Shoreline Recommendations, Structural

As a hub of activity, Kanes Marina supports many different types of recreation including motorized boating, kayaking, fishing, hiking, swimming, bird watching and dining. This variety of activities demands a variety of different shoreline stabilization treatments. Within the emergency boat launch area, where heavy trucks with trailers need access to the water's edge, a traditional type of structural stabilization is appropriate (fig.6.5.4 - C,D). Where lighter foot traffic is the primary mode of access, a non-structural, or biotechnical approach is recommended (fig. 6.5.4 - E,F).

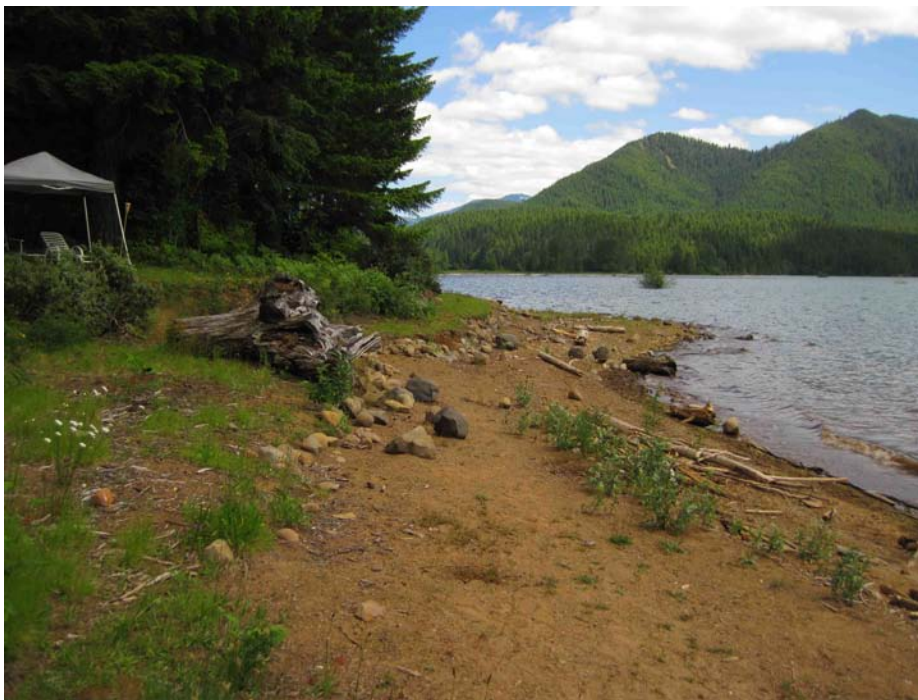
Fig. 6.5.5 - A; Kanes Marina Property Edge

Possible solutions to the problem of trespassing include physical barriers such as fences or walls along property lines, visual barriers such as vegetative screening, or greater distance between designated walking paths and private property.

One suggested solution is to create a vegetative buffer between paths and homes along the lake front. This proposal has met great opposition, as homeowners are equally protective of their views of the public land as they are of their own property.

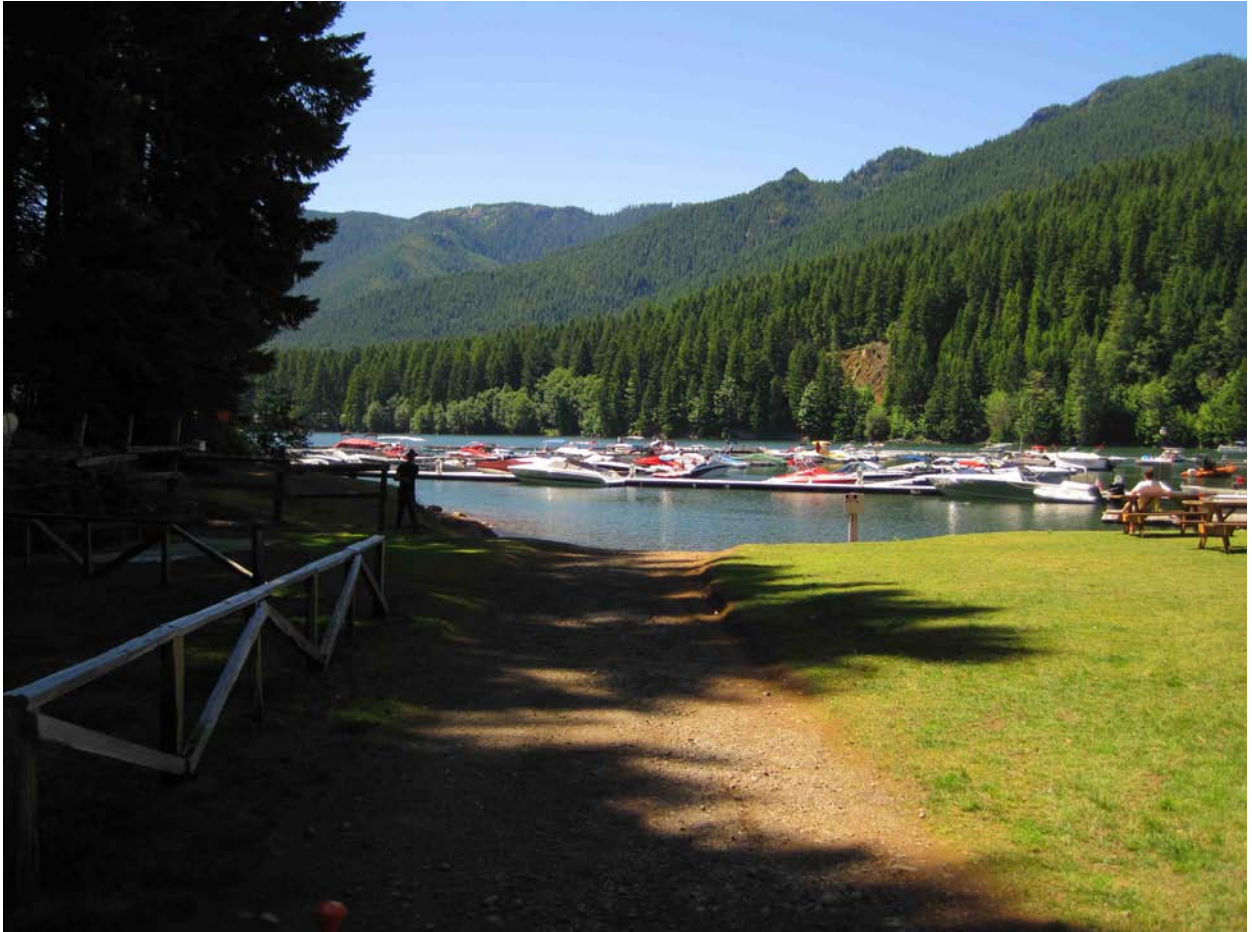
Fig. 6.5.6 - A; Kanes Marina (area to be dredged)

The current owner of Kanes Marina, is looking to remove 80,000 cubic yards of soil beneath the marina in an attempt to extend the boating season and increase boating accessibility. At this time, there are no plans regarding the relocation of the spoils from this project, however, the owner has expressed an interest in relocating this soil to a spot in the immediate vicinity in an attempt to keep the costs of this project at a minimum.

It is the recommendation of the design to relocate the spoils from this project to the proposed island areas as designated in the new design of the Detroit Flats area. As this soil is already from the lake bottom it will ecologically and geologically match – using this soil will also not affect the storage capacity of the lake.

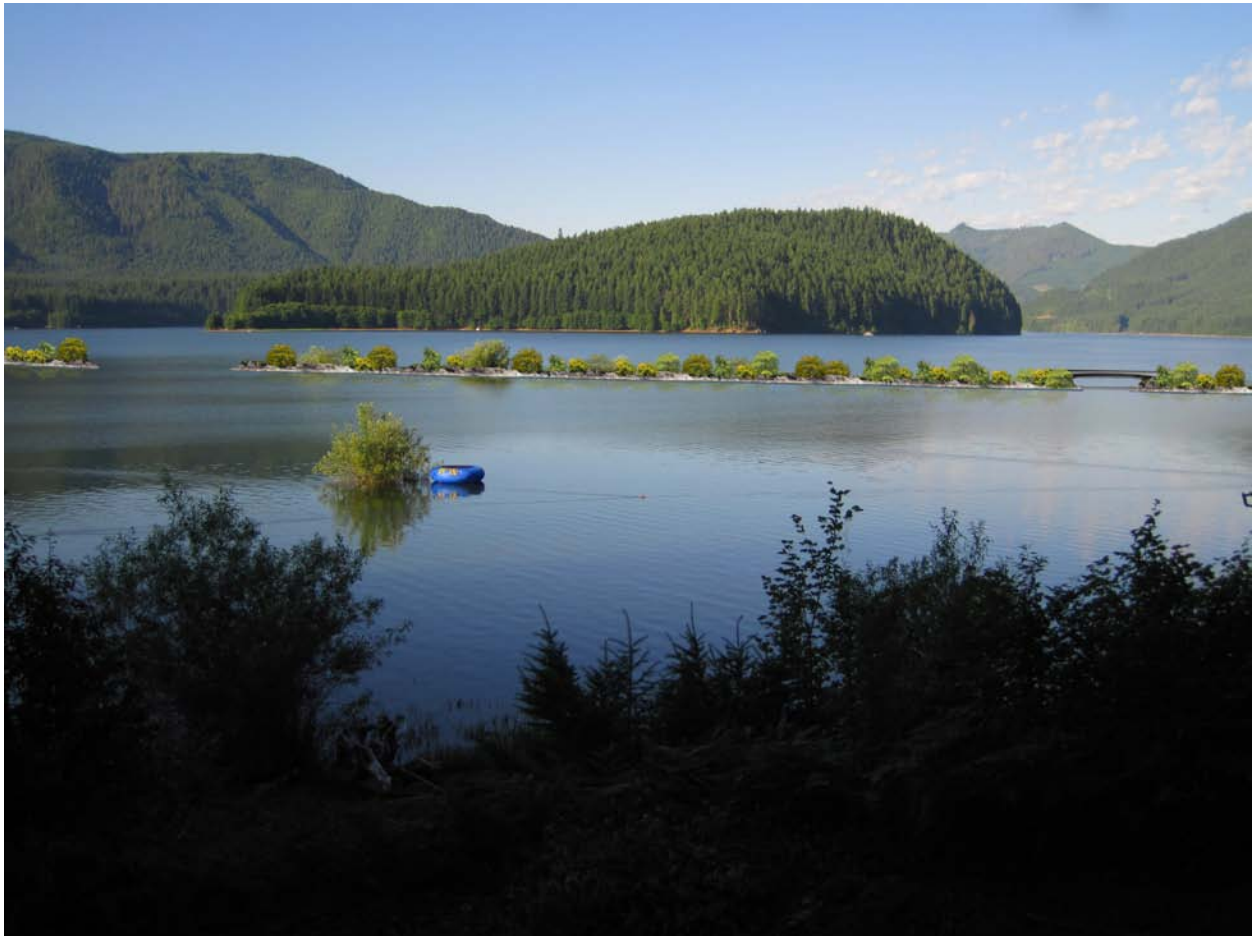
Fig. 6.5.6 - B; Detroit Flats (area to be filled)

The soil height in the creation of these new islands should not exceed a height of 1567.5 (see Pg. 46) and should be planted immediately after being placed.

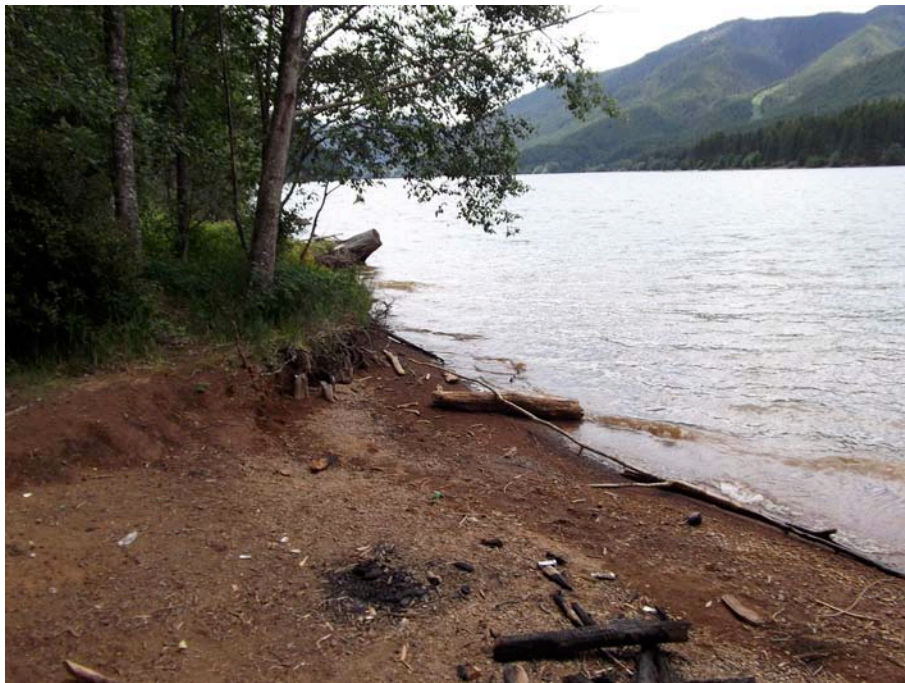
Fig. 6.5.7 - A; Kanes Marina Existing Beach/Fishing Area

There is a current demand in the Detroit Lake area for more fishing areas and ADA accessible fishing platforms. Although attempts have been made in other areas there is still a demand for more accessible fishing areas – especially in the Kanes Marina and Detroit Flats area. Fishing piers should be placed in easily accessible locations that are visible from a distance to promote use and interest.

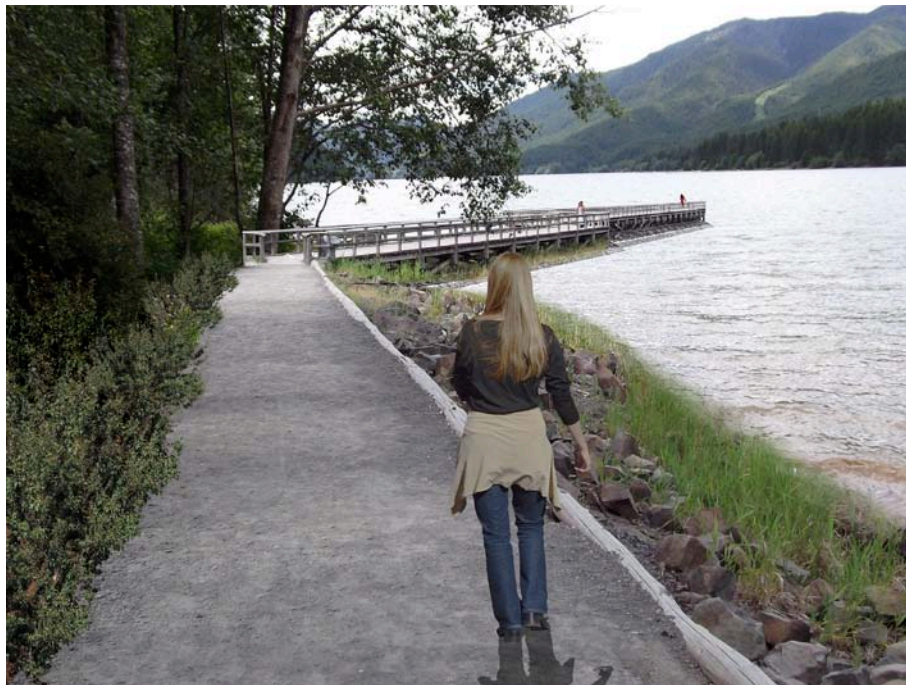
Fig. 6.5.7 - B; Kanes Marina Proposed Beach/Fishing Area

Most likely, new soil will be needed to help keep these structures in place, however, this soil can come from any number of the proposed dredging projects at Kanes, Piety Island or Detroit Flats.

The length of these piers still needs to be determined and will be based in part on the existing topography at the sites.

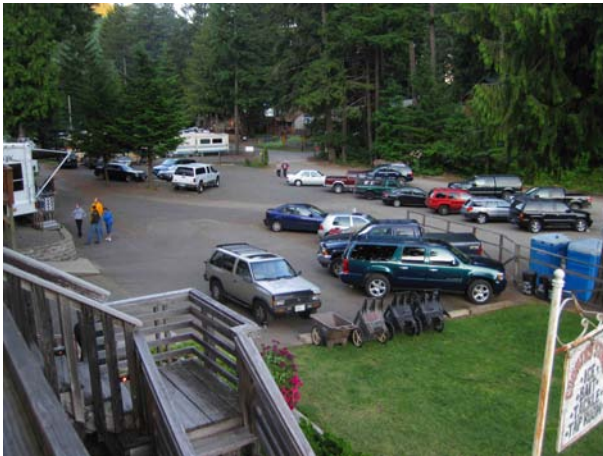
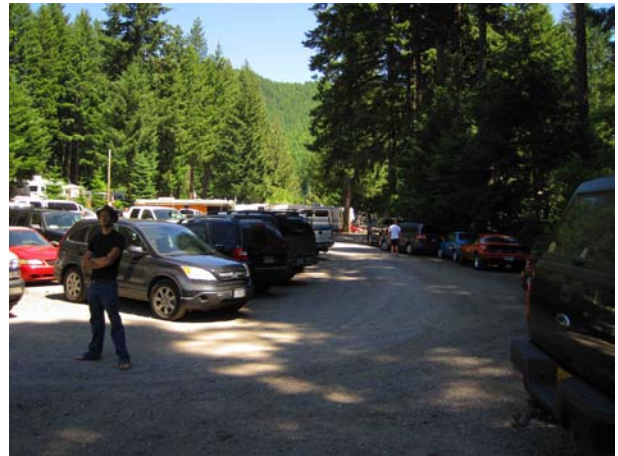
Fig. 6.5.8 - A, B; Kanes Marina Existing Signage

Signage is lacking greatly here. There is very little signage to direct visitors to places and very little signage to identify places. Kanes Marina has a few business signs. There are numerous “No Trespassing” signs near property lines.

In general, signage is greatly needed here for way finding and imageability.

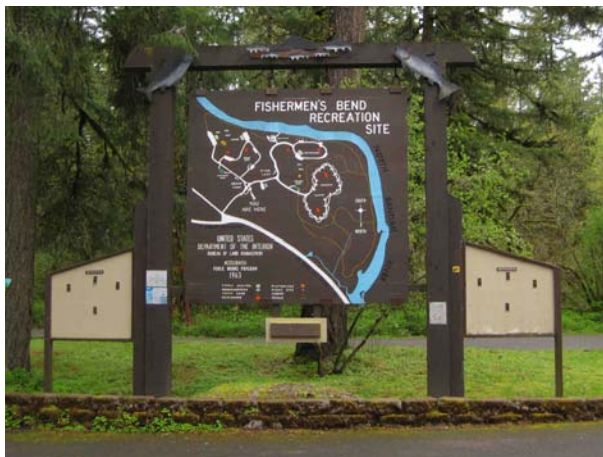
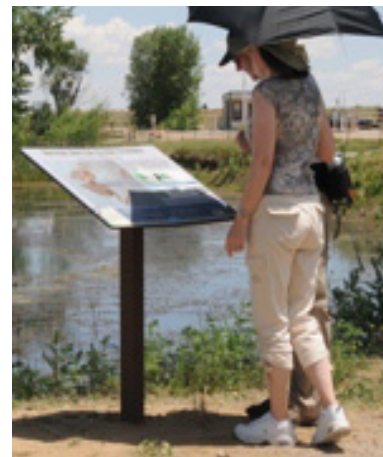
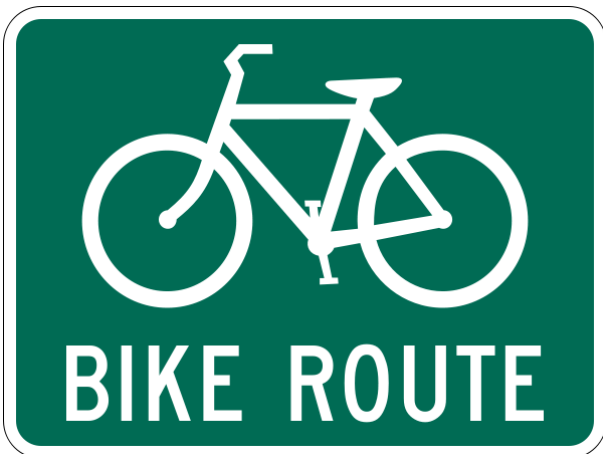
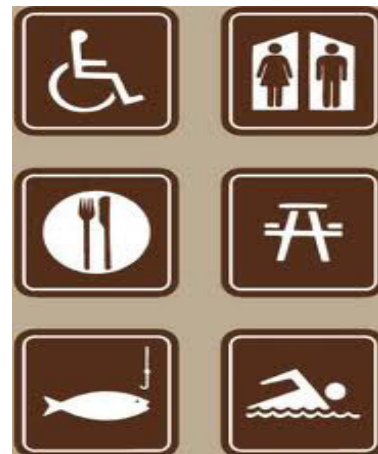
Fig. 6.5.8 - C-F; Kanes Marina Proposed Signage

Directional signs specific to pedestrian traffic include restroom signs, garbage/recycling facilities signs, fishing docks, ADA accessible routes, bike route signs, picnic tables, swimming areas, interpretive signs for natural processes, and restaurants or other business establishments.

Identity signage is also necessary to increase the imageability of Kanes Marina. A gateway, welcome or threshold sign letting visitors know they have arrived is critical to the imageability of the area.

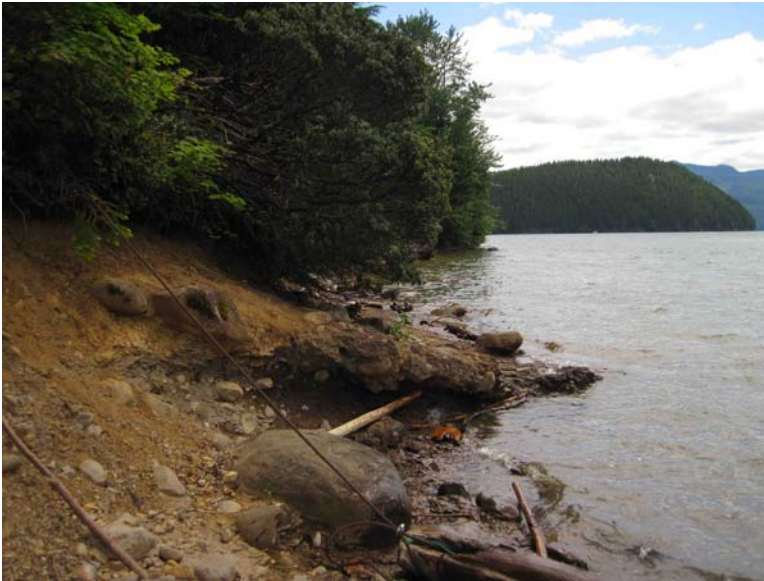
Fig. 6.5.9 - A; Kanes Marina Eroding Shoreline

Access to and from the water is limited in the Kanes Marina project area. Although the land is public, problems with local private property owners has continued to reduce ingress egress. The eroded shoreline also makes this accessibility more difficult as do the limited number of paths to and from the water. Fluctuating water heights throughout the year add yet another component to the problems of accessibility.

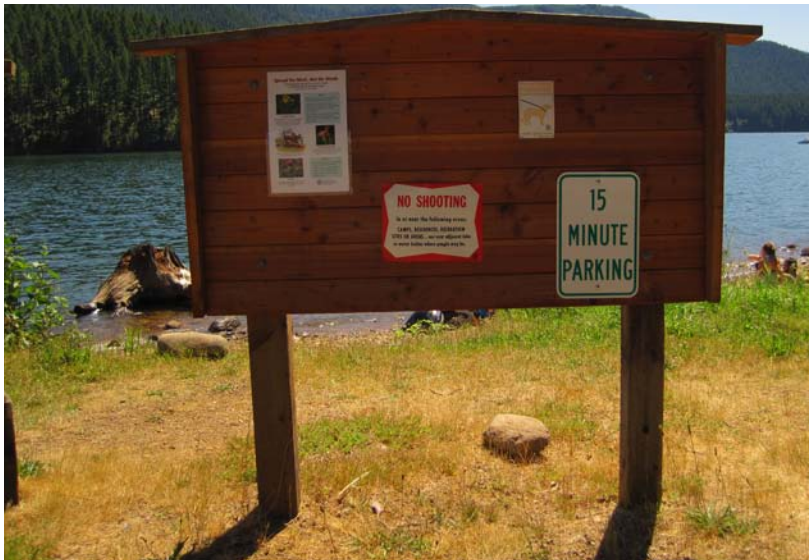
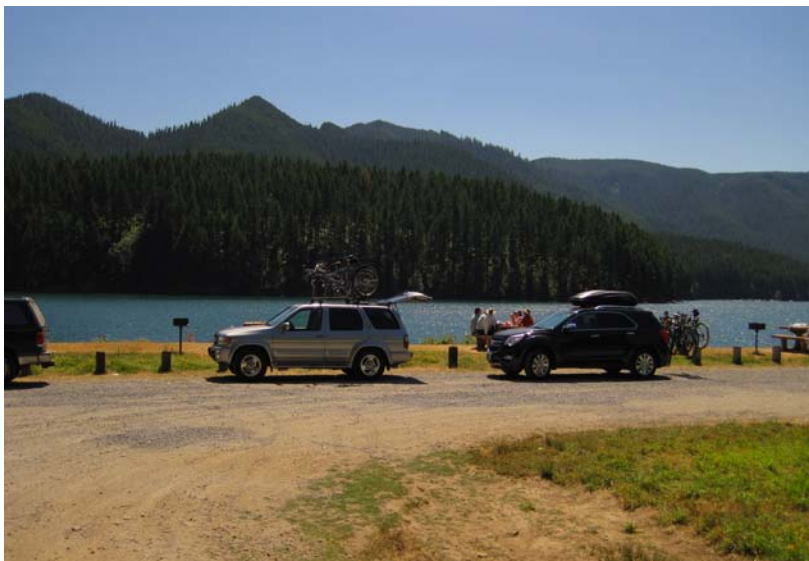
Visitors are forced to hunt for the trail under existing conditions. There is much room for improvement of these trail heads.

Fig. 7.5.2 - A; Detroit Flats Existing Trailhead Signage

Fig. 7.5.2 - B; Detroit Flats Existing Trailhead Parking

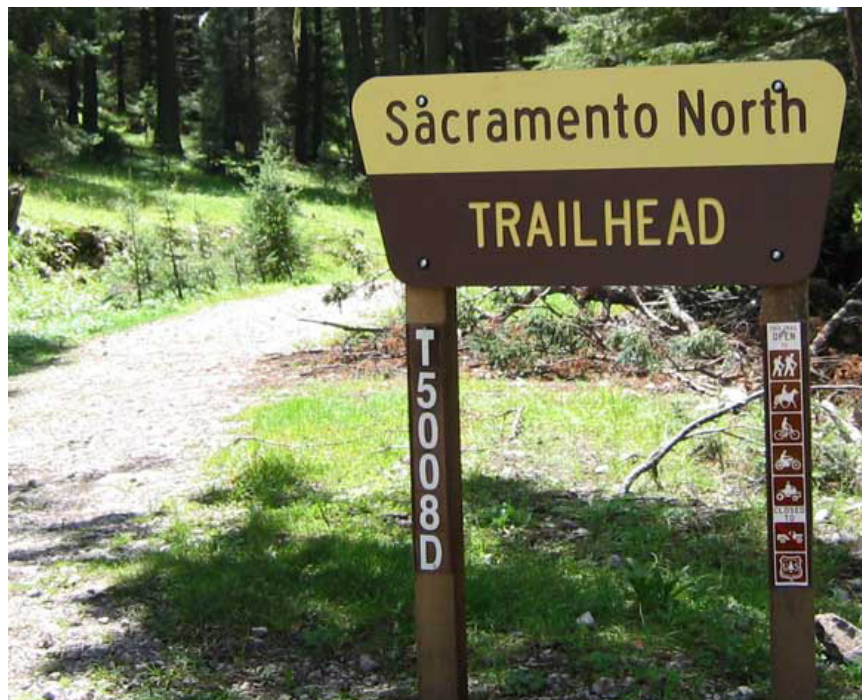
Fig. 7.5.2 - C-F; Detroit Flats Trailhead Recommendations

Trailhead signs and area maps are recommended. Trail destinations, distances and walking times should be included in signage information.

Trash and recycling receptacles should be installed at or near the trail head to reduce litter on the trail and bring visitors awareness to maintenance efforts.

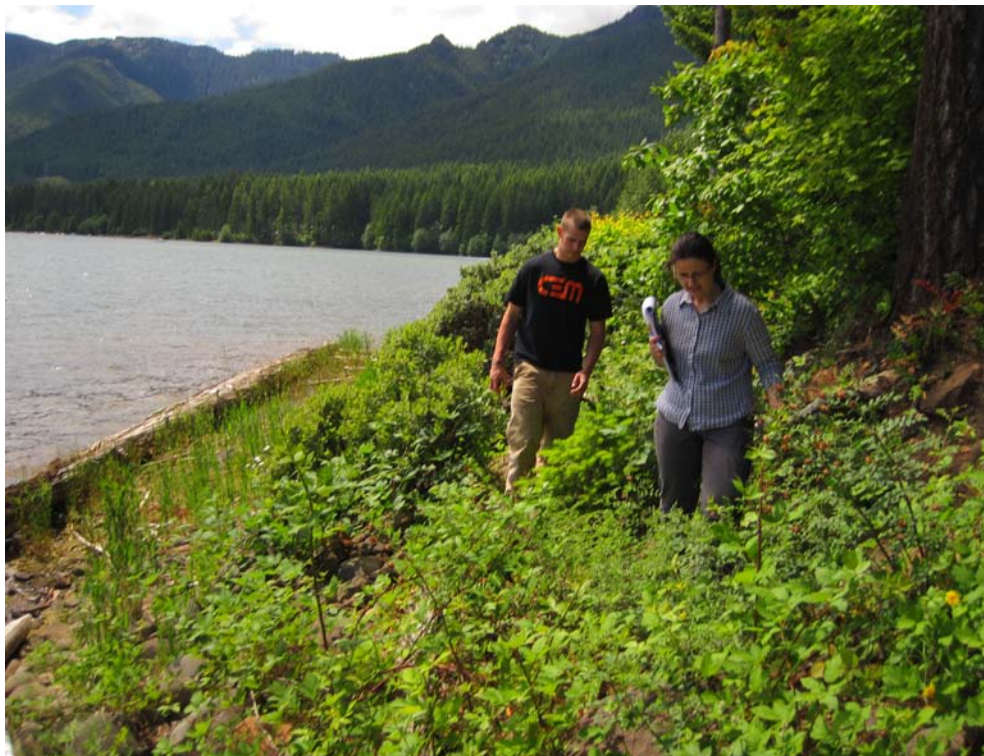
Fig. 7.5.3 - A-C; Detroit Flats Existing Trails

There is currently no continuous trail linking Kanes Marina and the Day Use Area at the Southeast end of Detroit Flats. A partial trail beginning at Kanes Marina follows the shoreline, then ends abruptly within a few hundred yards. Another trail begins at the Day Use Area and ends at the tip of Osprey Point when lake levels are high. When lake levels are lower and the land bridge between Osprey Point and Piety Island is above the water level, then there exists a trail that visitors can travel to reach Piety Island. Existing trails are rustic and do not accommodate visitors physical with disabilities such as individuals in wheelchairs or those using walkers.

There are currently no designated resting places along the trails, such as benches or covered areas.

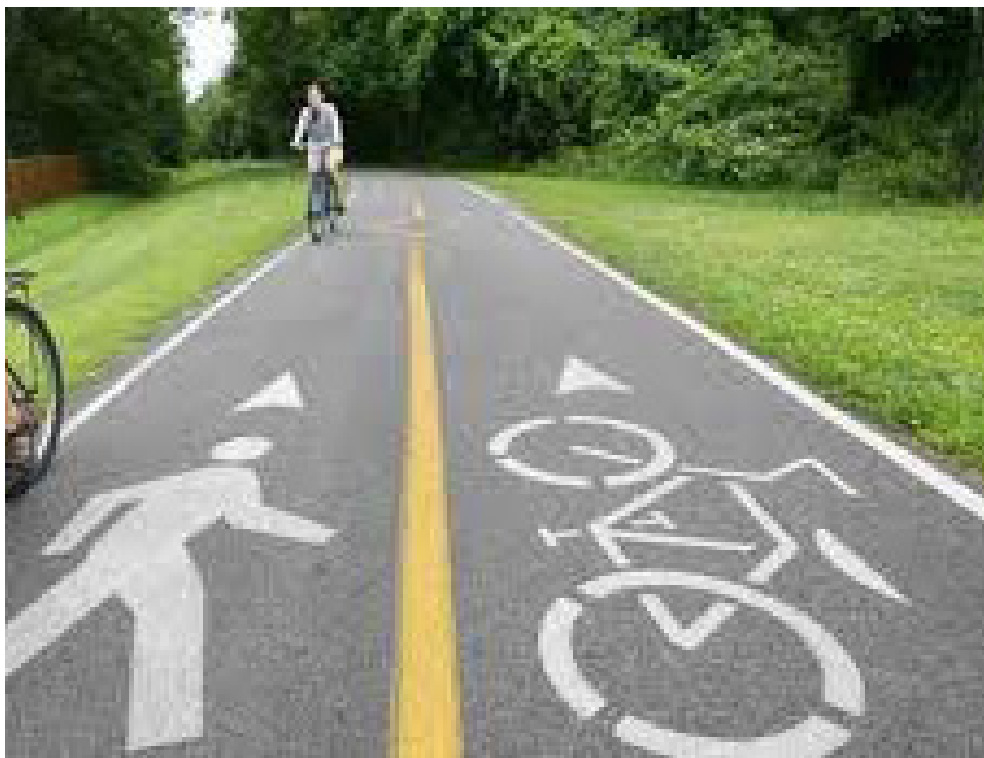
Fig. 7.5.3 - D-G; Detroit Flats Trail Recommendations

There are different user groups that will need different types of paths, including paved paths, rustic campground paths, hiking and adventure trails. All trails within the Detroit Flats Area are to be clearly marked with trail head signs and directional signs at intersections.

Fishing and viewing will occur along the trails. Trails should meander as they near the waters edge. Trails will also need to be widened at particular points of interests to accommodate for where people are likely to gather for fishing, bird watching, setting up coolers, chairs, etc.

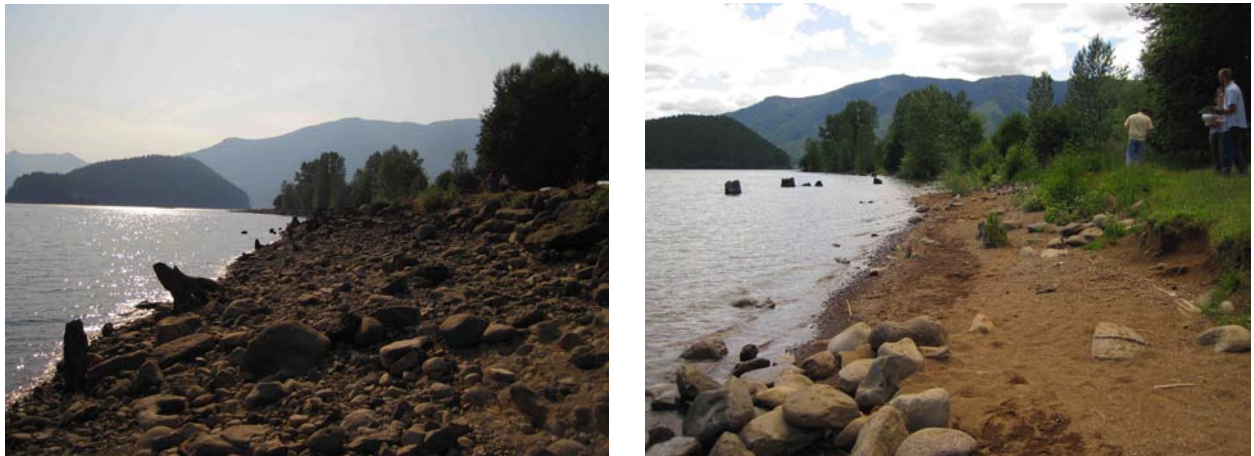
Fig. 7.5.4 - A,B; Detroit Flats Existing Shoreline Erosion

Bank stabilization is particularly important at locations along the shoreline within the three specified areas of this project, Detroit Flats (including Kanes Marina), Piety Island, and Santiam Flats.

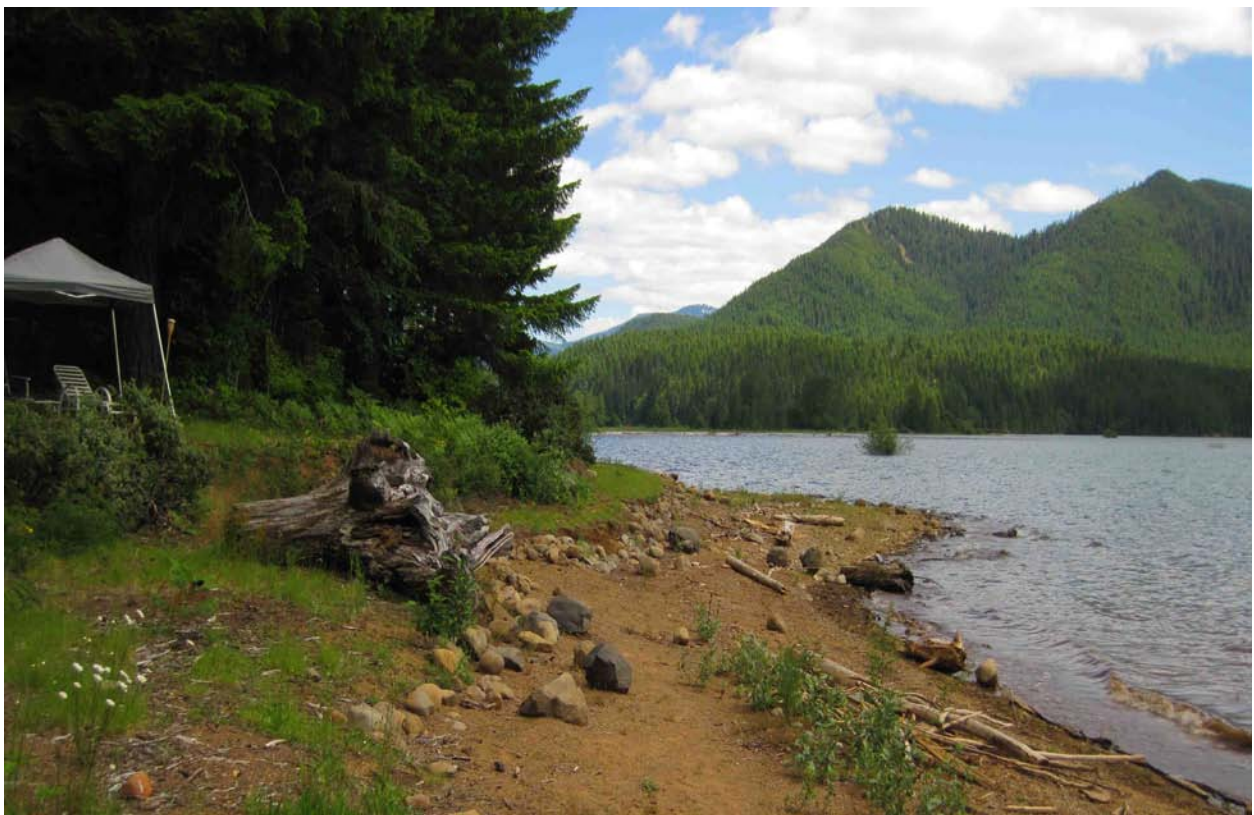
Fig. 7.5.5 - A; Detroit Flats Existing Private/Public Property

Many private land owners have expressed concern for privacy and safety, stating that theft and other criminal activity is a problem due to the close proximity of lake visitors to their land and homes.

Possible solutions to the problem of trespassing include physical barriers such as fences or walls along property lines, visual barriers such as vegetative screening, or greater distance between designated walking paths and private property.

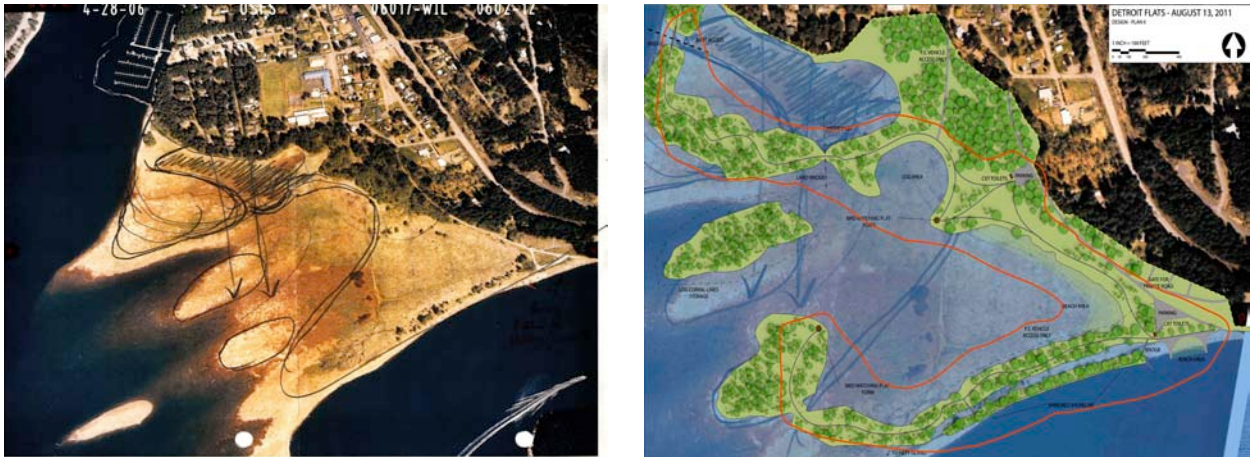
Fig. 7.5.6 - A,B; Detroit Flats Islands Existing Conditions

Currently the Detroit Flats area has a number of islands that emerge from the lake based on the fluctuating water heights. These islands, while not formally defined, are an important part of the topography in this area. These high spots in the water are dangerous for boaters and should be addressed as such. Furthermore these high spots provide excellent fishing areas for osprey and eagles.

The design recommends formalizing these islands to create a consistent chain of recognizable islands. These islands should be an average height of 1569' and should follow the placement and size as shown on the design. The placement of these islands is based on the existing high topographic areas which should make them easy to define.

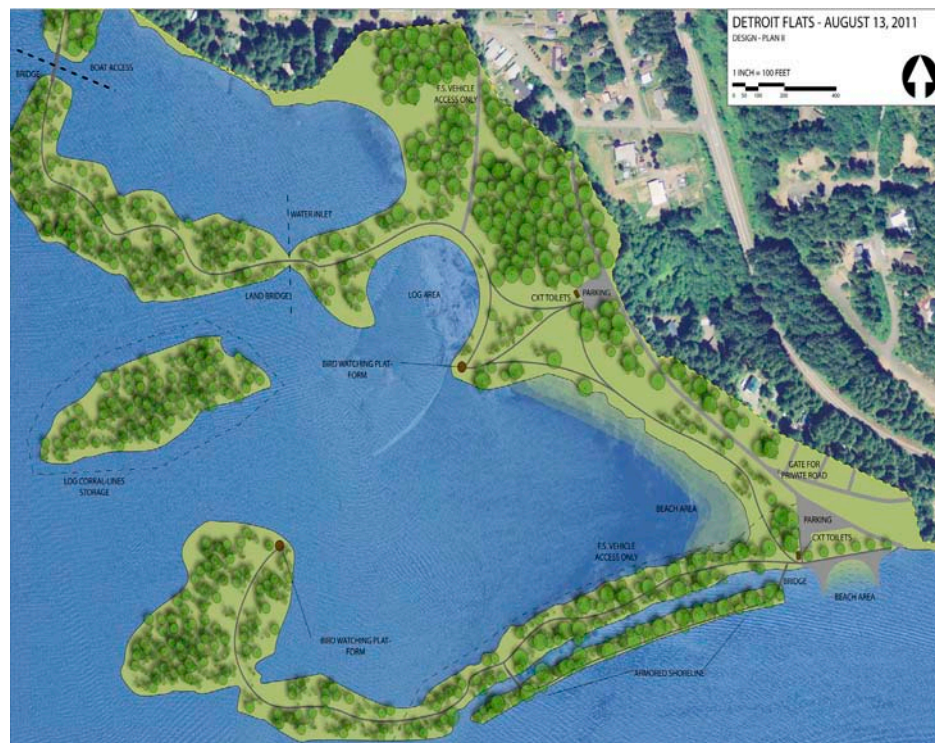
Fig. 7.5.6 - C; Detroit Flats Islands Proposed Plan

Removed tree stumps should be replaced on the shoreline of these islands to promote habitat and help contain the soil. Plants should be selected based on their height, resilience and adaptability. Plants should not grow above 10' as they will obstruct onshore views to the lake and island.

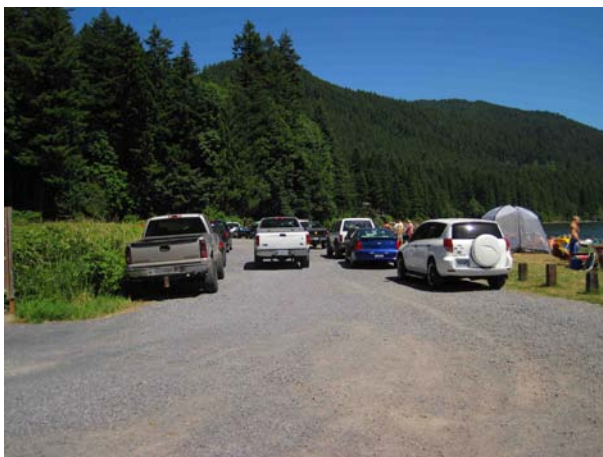
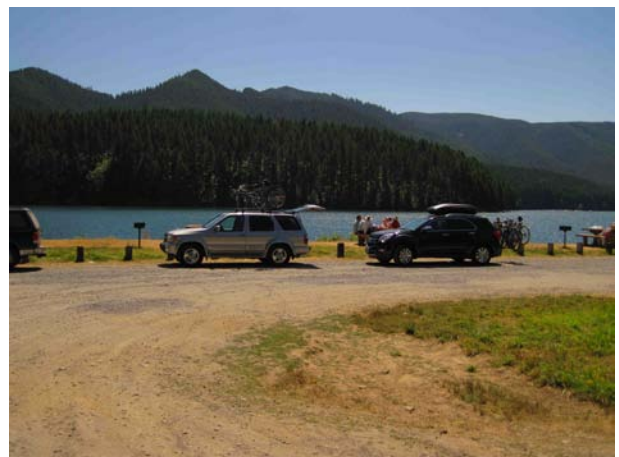
Fig. 7.5.7 - A,B; Detroit Flats Parking Existing Conditions

Currently the parking at Detroit Flats is limited and poorly laid out. With a high number of visitors every year, especially during peak times in the summer months, this parking lot is not equipped to meet the demand. The existing compacted gravel creates dust and requires yearly maintenance. Furthermore, this gravel severely diminished the accessibility for the site – especially for people with disabilities.

A large planted area in the middle of the parking area occupies a large portion of the site and is not being used to its best and highest use. The parking area is aesthetically deficient and could use serious improvements.
