# Detroit Lake Restoration and Enhancement Design Booklet

U.S. Forest Service  
Detroit Ranger District

October 7, 2011

Prepared by: Alex Misar and Lytton Reid

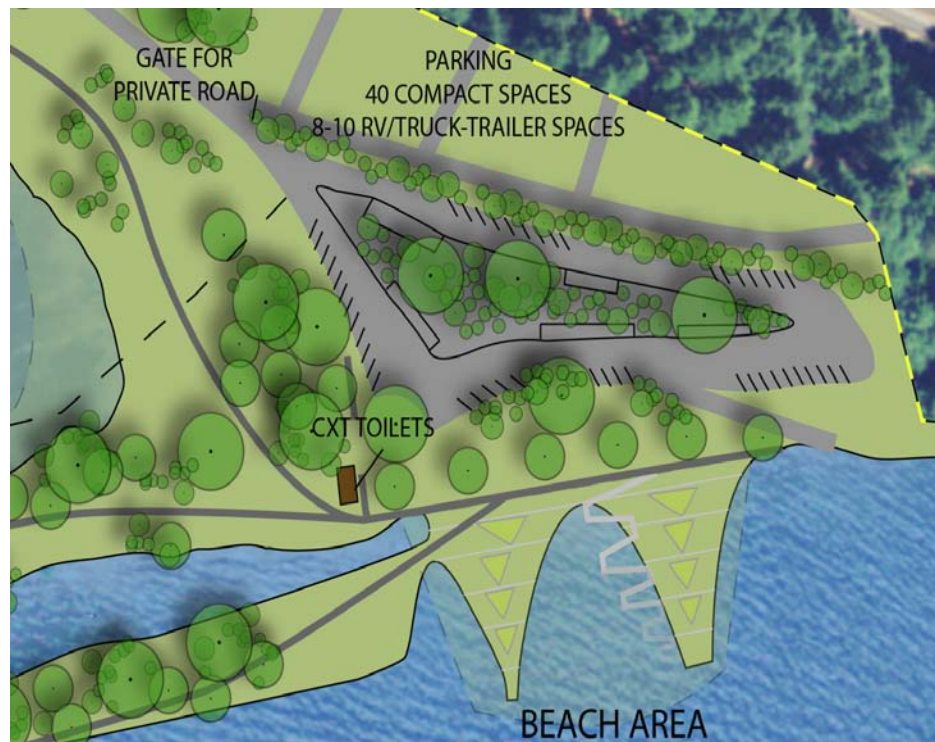
Fig. 7.5.7 - C; Detroit Flats Parking Proposed Plan

In an effort to maximize space and provide more parking in the Detroit Flats area the design recommends the installation of a new parking lot in approximately the same location as the existing one. This parking lot should be asphalted with an increased number of parking spaces. By moving the lot further away from the shore and utilizing the plated area in the middle this parking area could accommodate up to 65 automobiles, including designated RV and ADA accessible spaces.

In addition to the primary parking area at Detroit Flats a second parking area has been included in the design just NW of the current parking lot. This parking area, while smaller than the primary one, should be designed to accommodate 10-15 automobiles.

Both parking areas should accommodate disabled parking with priority parking for these patrons near the facilities and trail heads where appropriate.

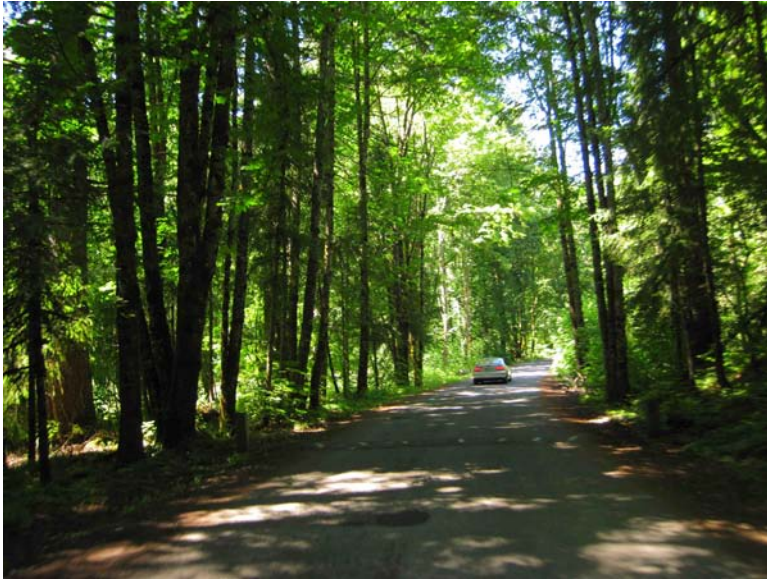
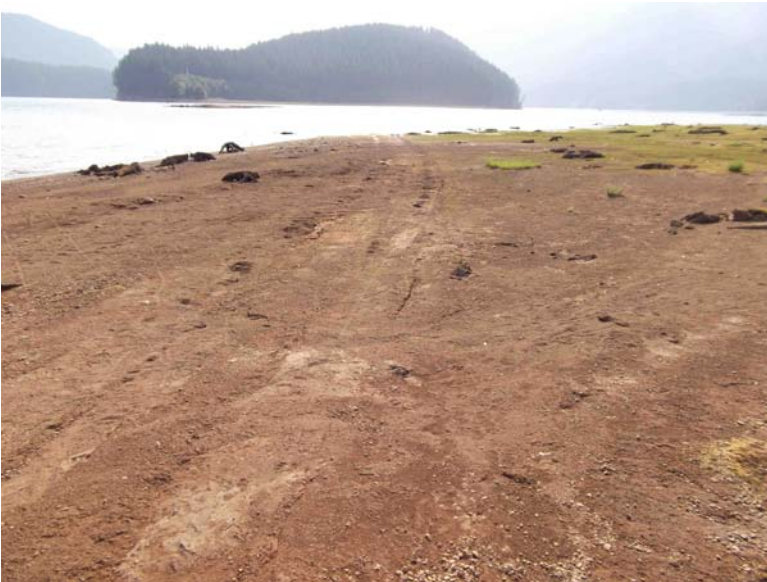
Fig. 7.5.8 - A,B; Detroit Flats Access Existing Conditions

The overall access to the Detroit Flats area is good with the exception of a few key areas. The primary access point to the day use area is down Detroit Rd. which, despite the lack of signage (see Pg. 52) provides easy access to the site. However, public access along the shoreline has been disrupted by the encroachment of private properties and a lack of trails, signage or way finding elements. Furthermore, these areas do not provide universal access or accommodate in any way disabled users.

To increase accessibility in this area the design recommends the installation of a number of new trails. These trails should be constructed from asphalt and be fully ADA accessible. New trail heads, signs and way finding elements should be employed throughout the site to designate areas and access points.

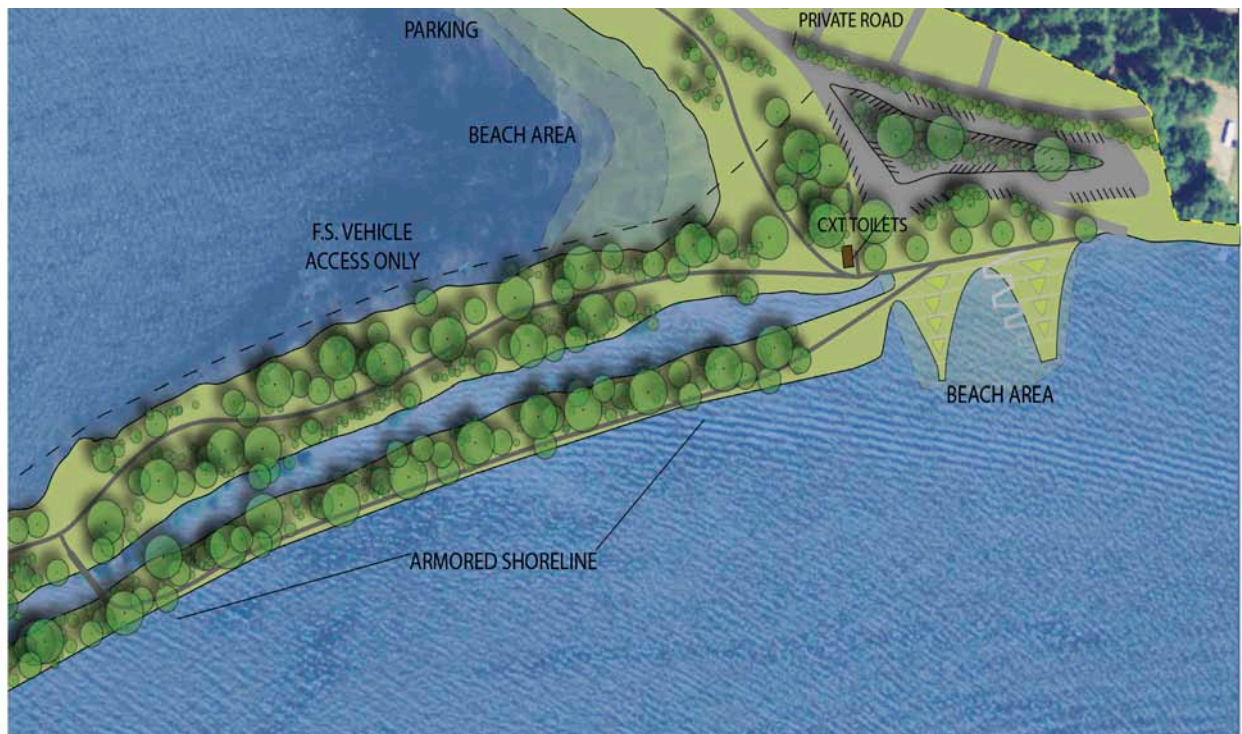
Fig. 7.5.8 - C; Detroit Flats Access Proposal

These trails have been moved away from the shoreline in an effort to reduce conflict with local residents and private property owners. Trails, instead, have been moved along the chain of islands as recommended by the new design of Detroit Flats.

Bridges (see Pg. 66) connect these paths where needed and still allow boat access in key areas.

Pedestrian access is still available down Patton St., however, vehicle access is restricted in this area to Forest Service Vehicles only. Similarly, access to Piety Island via Detroit Flats is available only to Forest Service vehicles as well. This route to the island, available only in the winter, should follow the existing road as much as possible and may need to be moved in the future to accommodate the design work outlined in this document.

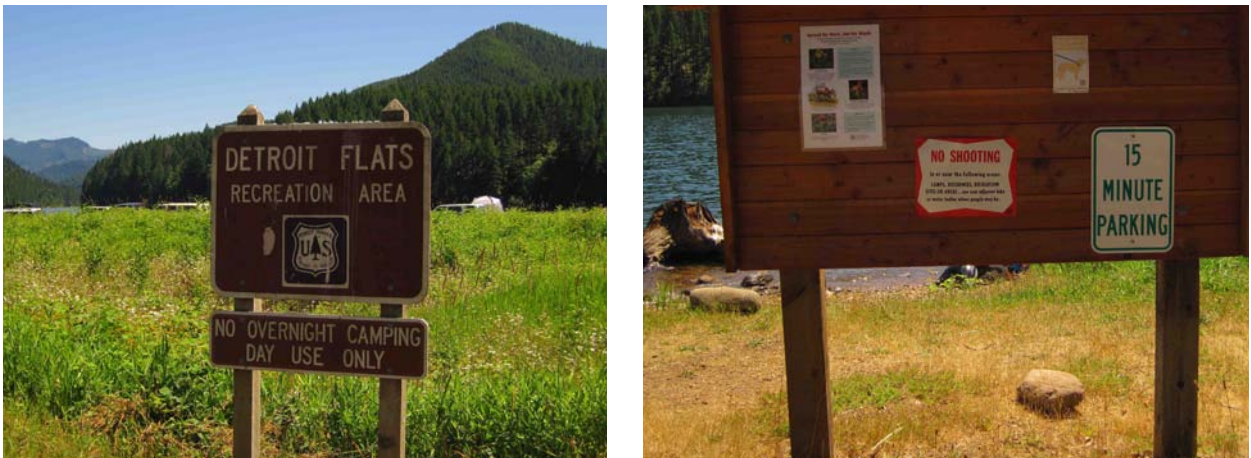
Fig. 7.5.9 - A,B; Detroit Flats Signage Existing Conditions

In general, signage is greatly needed here for wayfinding and imageability. Existing signs are primarily posted for the purpose of deterring unlawful activities. Additional signs are needed to promote desirable activities, make visitors feel welcome and foster a sense of stewardship for the land.

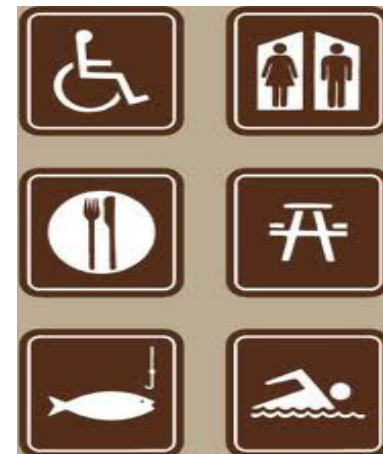
Fig. 7.5.9 - C-G; Detroit Flats Signage Recommendations

Directional signs specific to pedestrian traffic include restroom signs, garbage/recycling facilities signs, fishing docks, ADA accessible routes, bike route signs, picnic tables, swimming areas, interpretive signs for natural processes, and restaurants or other business establishments.

Identity signage is also necessary to increase the imageability of Detroit Flats. A gateway, welcome or threshold sign letting visitors know they have arrived is valuable to the imageability of the area.

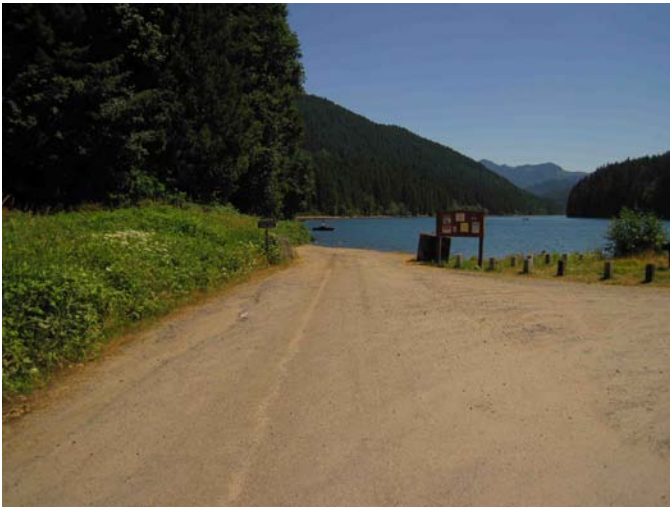
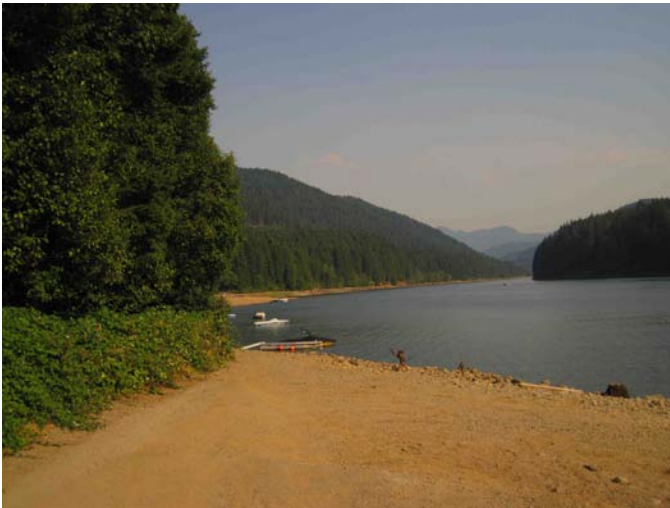
Fig. 7.5.10 - A,B; Detroit Flats Boat Access Existing Conditions

The old road currently provides an informal boat launch in the SE corner of the site (Fig. 7.5.10 - A,B), next to the day use area, however motorized boat access here is discouraged—despite this fact, it is a common occurrence. Boats are commonly docked here on the shoreline by day use boaters who are looking to spend some time ashore.

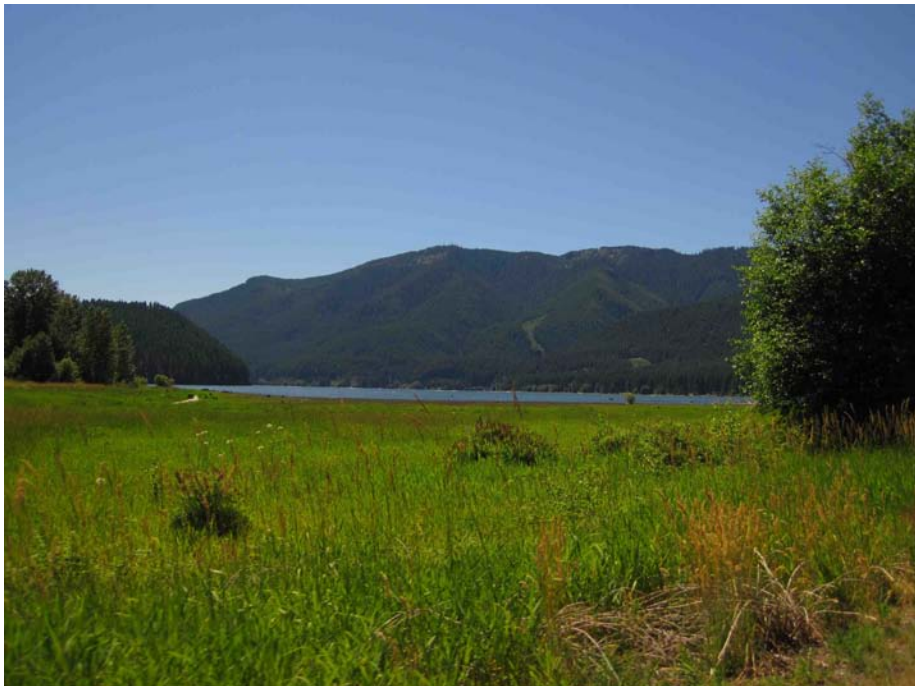
Fig. 7.5.11 - A; Detroit Flats Bird Watching Existing Conditions

Detroit Flats is well known as a bird watching area. With a unique ecosystem and resting point for migratory birds, Detroit Flats has made its way onto the Audubon societies list for top 100 bird watching areas. However, despite the nature of this site there are few opportunities or areas to actively view birds. Furthermore, the habitat here is being threatened by increased boating, a degraded environment and invasive plant and animal species.

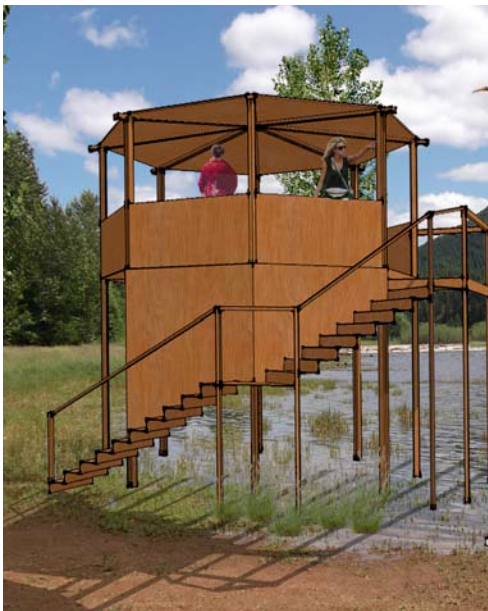
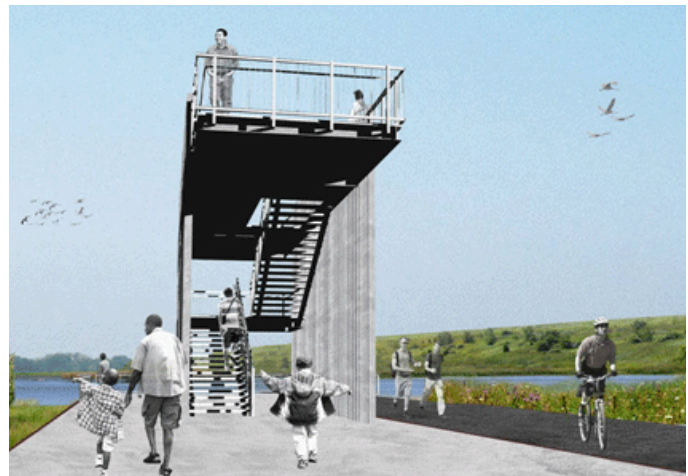
Fig. 7.5.11 - B,C; Detroit Flats Bird Watching Platform Suggestions

In an effort to strengthen this character of the site the design recommends the installation of a number of bird watching platforms which will provide strong views into the landscape and to bird habitat. These platform, positions across form one another in the new bay area, should be constructed from wood. Architecturally, these structures should match Forest Service design guidelines that are consistent with the Cascadian Style. These structures should sit above ground 5-10' and provide users with long, unfettered, views of the landscape.

The bird watching structure on the east side of the bay should be designed to accommodate wheelchairs and other disabilities with a ramp that allows access to at least the first tier of the platform structure, which will afford raised views of the surrounding area. This will most likely require a combination of topographic changes in the landscape immediately surrounding the structure, as well as a switchback ramp system.

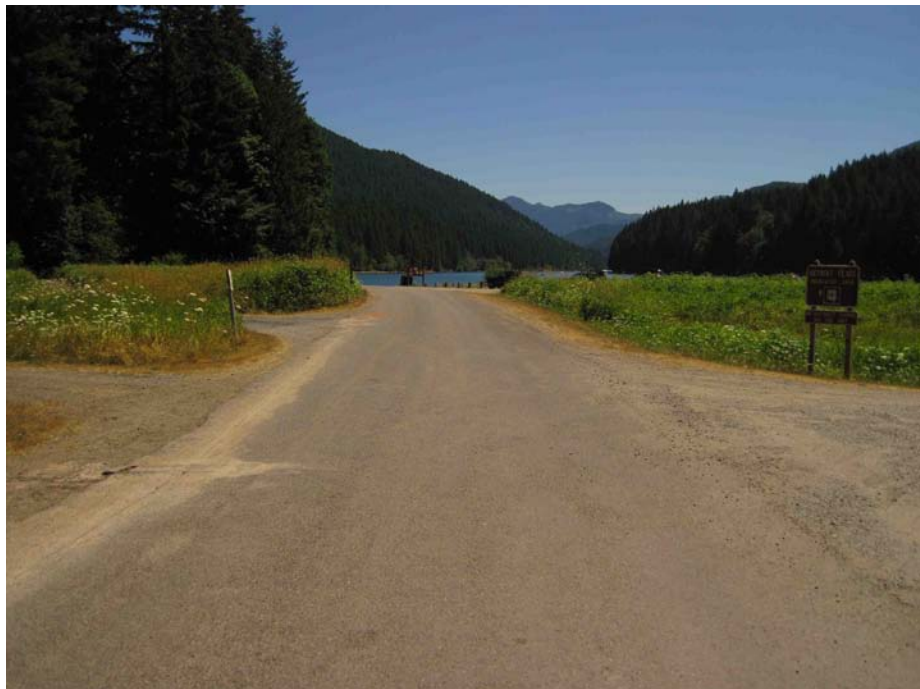
Fig. 7.5.12 - A; Detroit Flats Roads Existing Conditions

The current roads in the Detroit Flats area, while functional, could use improvements. In many places potholes and uneven surfaces make driving difficult or unpleasant. More so, gravel roads on site create dust and require maintenance.

Roads should be asphalted where possible and systems employed to mitigate storm water from runoff. These systems could include bioswales, flow through planters, or wetland mitigation. Gravel roads should be replaced where possible with asphalted for easier access and less maintenance. Connections to the new parking lots should be taken into account when designing these roads.

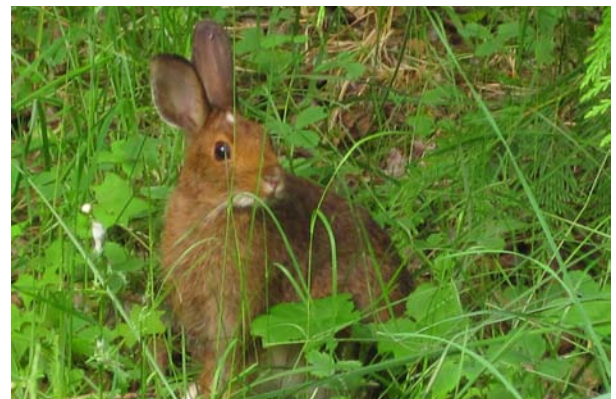
Fig. 7.5.13 - B-D; Detroit Flats Habitat

Strong measures should be taken in the design and construction phases of this project to ensure that this area will be preserved and improved upon as much as possible. Specifically, the design recommends the removal of all invasive species and the replanting of native plants that encourage wildlife. Habitat for birds, fish and other animals must be preserved at all costs. Bird posts should be included in the design for Osprey nests. Snags should also be included in the planting of this area.

Existing stumps that will be removed in the construction process should be replaced along the shoreline to provide habitat and shoreline stabilization. It is important that in the work done here designers work closely with wildlife and fish biologists to achieve the best possible outcome.

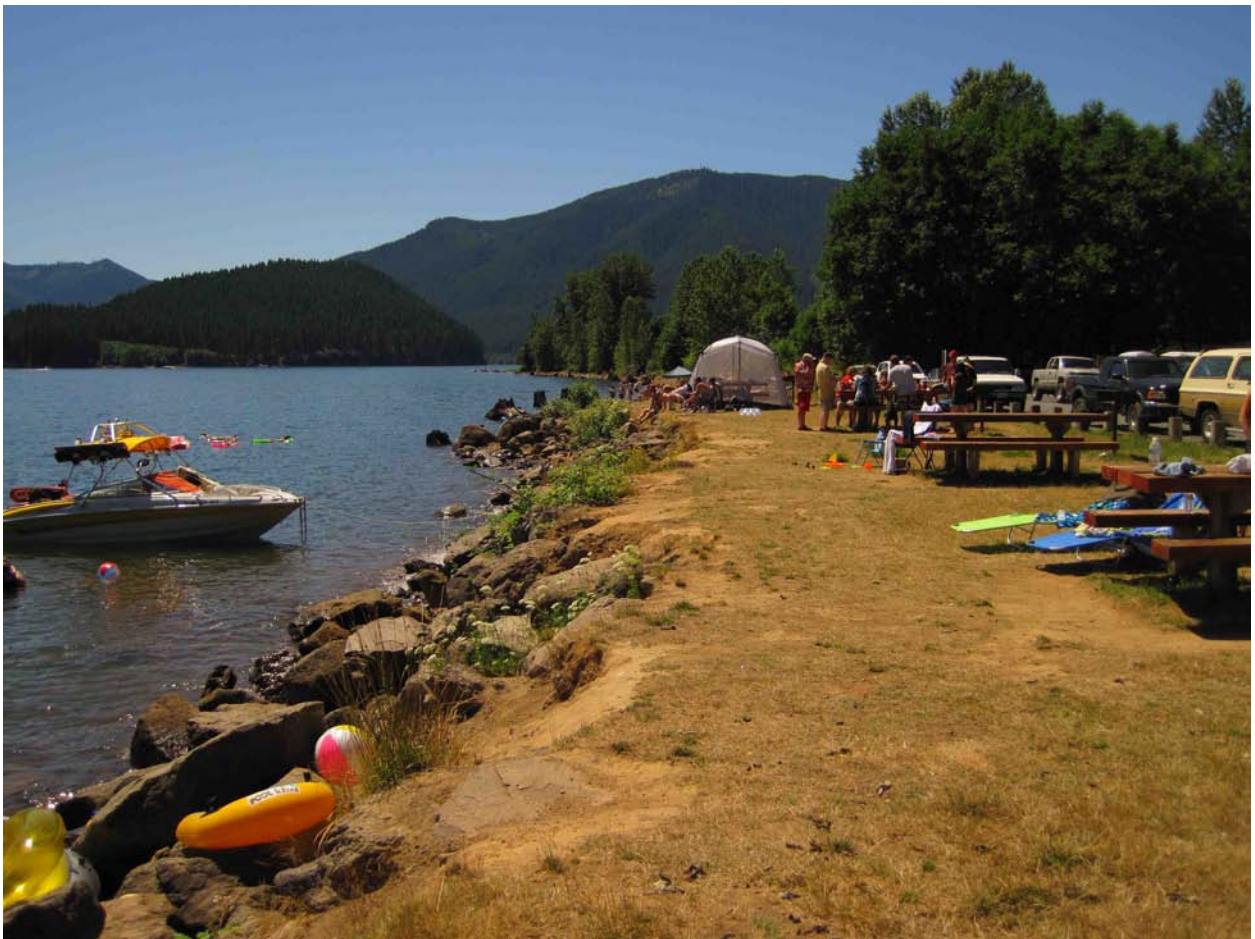
Fig. 7.5.14 - A; Detroit Flats Existing Primary Day Use Area

Riprap treatments of parts of the shoreline here have helped to preserve some integrity, but most of the area is still in need of repair and enhancement.

A comprehensive wholistic plan for this area includes a shoreline stabilization strategy, improved restroom facilities, and the enhancement of desired and popular activities such as bird watching, swimming, picnicking, fishing, boat mooring, kayaking, hiking and bicycling.

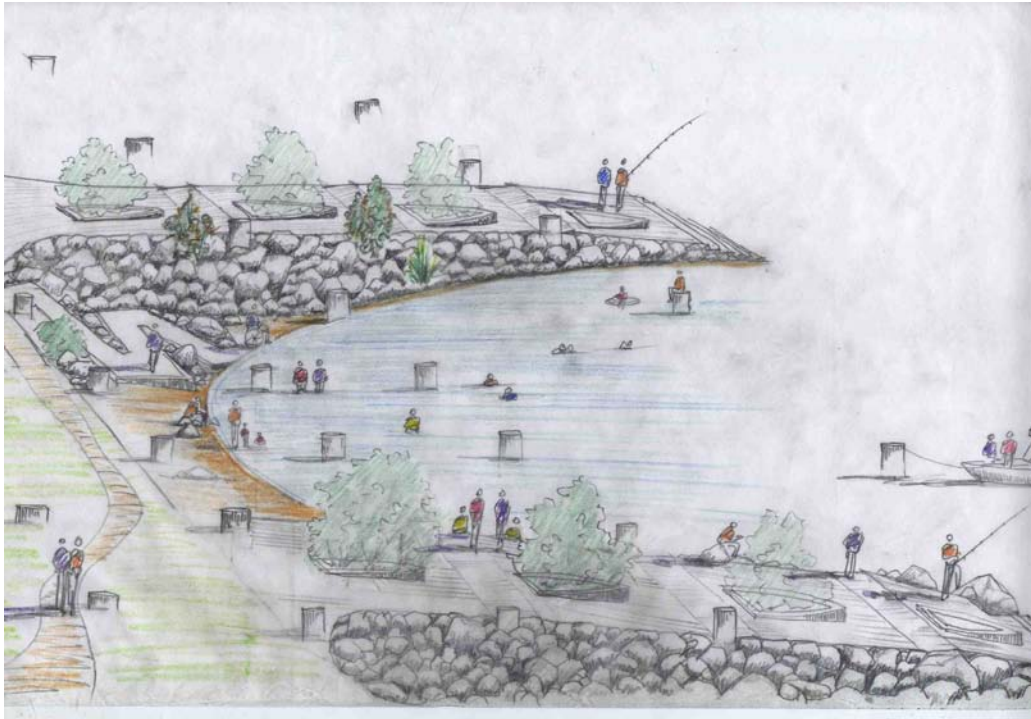
Fig. 7.5.14 - E,F; Detroit Flats Day Use Area Proposal

This beach area design combines ADA accessible fishing platforms with boat mooring stations, while accommodating swimmers and floaters in a safe bay, protected from boats and fishing tackle. Large logs, placed vertically on a grid pattern provide not only essential habitat for fish and other aquatic creatures but also can be used as anchors for mooring boats (outside of the designated shoreline water access area). Deeply anchored, these logs also reinforce shoreline stability, while adding a rhythmic metering to the landscape aesthetic, reminiscent of the forests that once inhabited this area as well as the agricultural forms supported by the creation of the Detroit Dam.

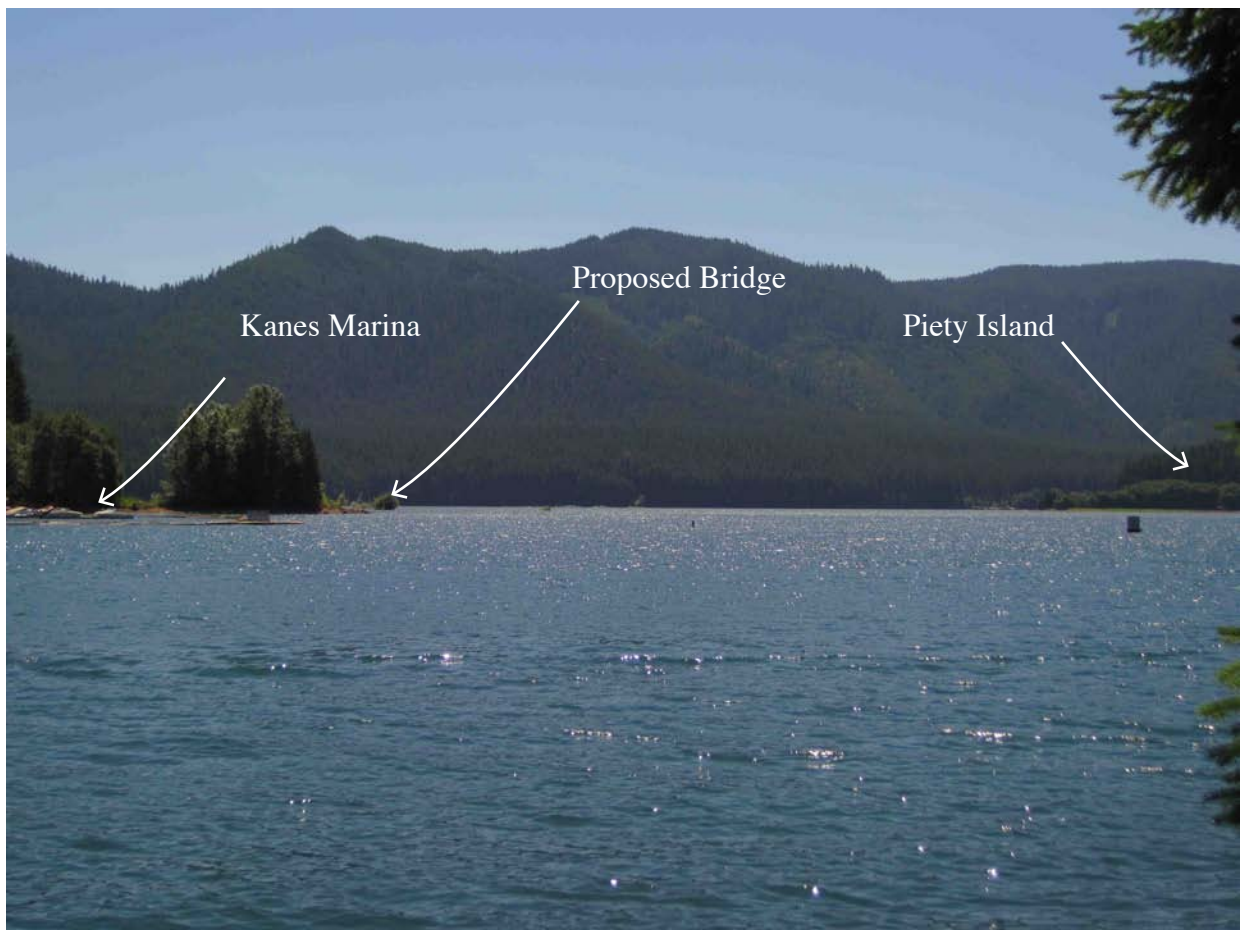
Fig. 7.5.15 - A; Detroit Flats Existing Conditions (Without Bridge)

The creation of an island chain in the Detroit Flats area brings with it the need for access to the islands. Specifically, in an effort to accommodate boaters and pedestrians the design requires the construction of a number of bridges and one land bridge with water culvert.

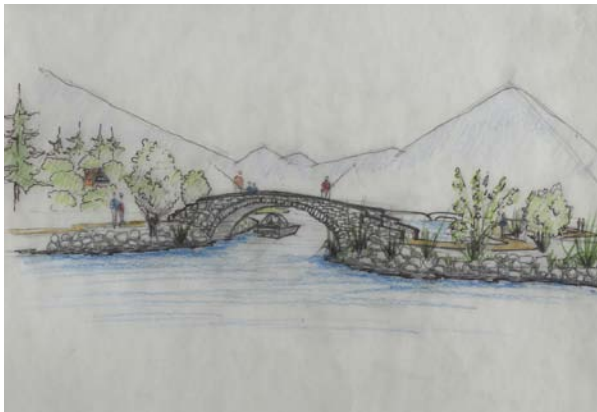
Fig. 7.5.15 - B,C; Detroit Flats Islands with Bridge Proposal

Other bridges at Detroit Flats do not require boat access underneath and therefore require less demanding engineering. These bridges should still conform to ADA guidelines as well as Forest Service design guidelines that are consistent with the Cascadian Style. These bridges may be constructed from wood or metal and need only be 6' wide with railings.

The land bridge and water culvert in the middle of the design area should be large enough for a 6' wide path to cross over the top but wide enough so that large flows of water can move underneath it. It is the primary concern of this design component that safe access can be given and that water will not stagnate in this area.

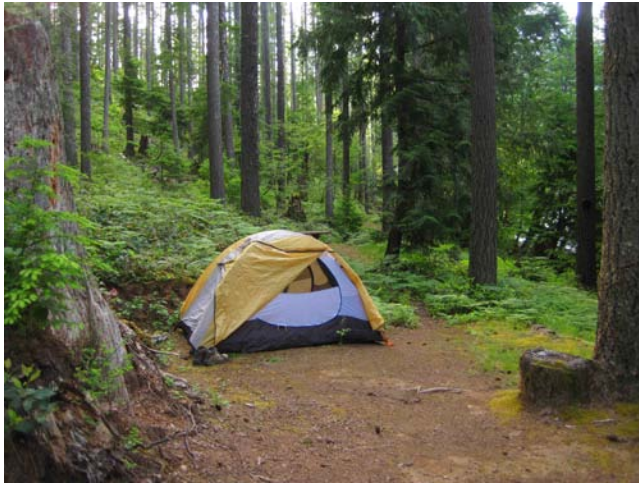
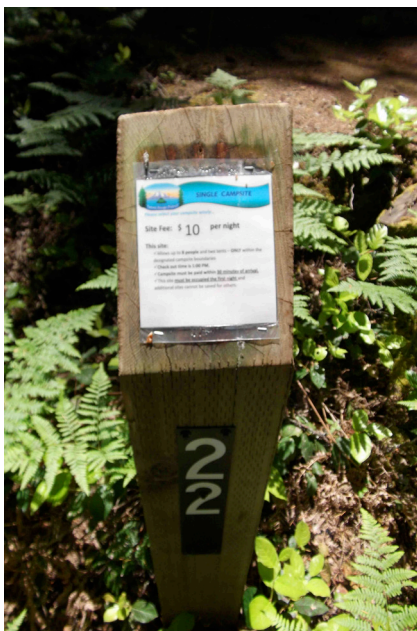
Fig. 8.5.1 - A,B; Piety Island Campsite Existing Conditions

Campsites at Piety Island seek a number of improvements to maximize the camping experience and accessibility. Specifically, access to the campsites from the shoreline is undefined and needs improvement. Furthermore, access to the campsites from the path system, while defined, could use improvement including new signage, paths and stairs where appropriate. The existing campgrounds also have little privacy from one another and are poorly defined both in location and site to site.

The design recommends improving these campsites so as to better define their location and boundaries, as well as provide increased screening and privacy. Specifically, campsites should have clearly defined paths leading to them and stairs where necessary. New signage should clearly demarcate the campsite number where the campsite trail meets the main trail.

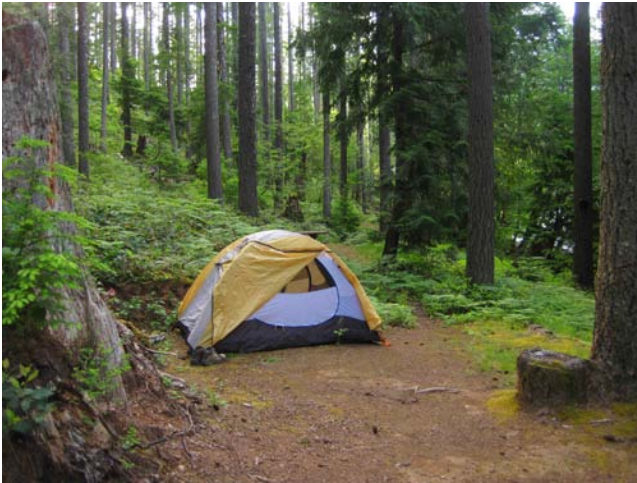
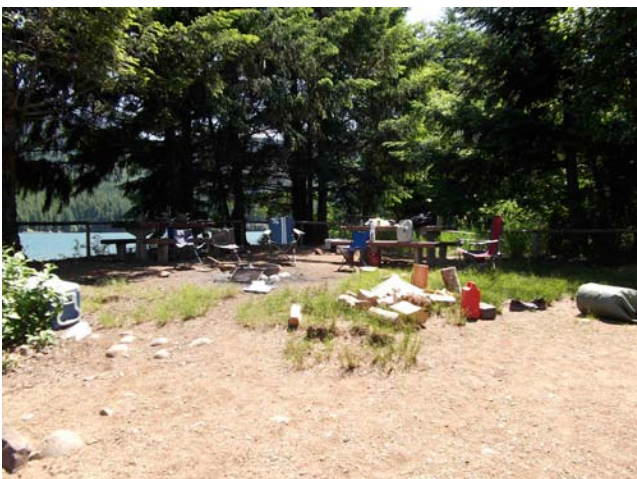
Fig. 8.5.2 - A,B; Piety Island Campsite Privacy Existing Conditions

Due to their layout and low numbers of surrounding vegetation the current campgrounds at Piety Island have little privacy and feel exposed. Views into adjoining campsites diminish the privacy and intimacy of the camping experience as well as create a feeling of uncomfortableness and vulnerability. Furthermore, the want for nature and a natural camping experience cannot be appropriately achieved given this camping style.

It is the recommendation of the design to increase vegetation between and around campsites so as to block views in and out of campsites. This increase in vegetation will help to maximize privacy as well as create a more natural aesthetic.

These vegetative screens should utilize plants of a medium height (4-10') with a dense growth that are native and tolerant of site specific conditions (See Appendix). Plants should also be chosen on their resilience to human use (ex. firewood, marshmallow sticks, etc.). Establishing these plants will take time and will require protection to ensure their survival during the first year or two. Temporary wood structures can be placed at the edge of campsites to deter trampling of these new plants during this time.

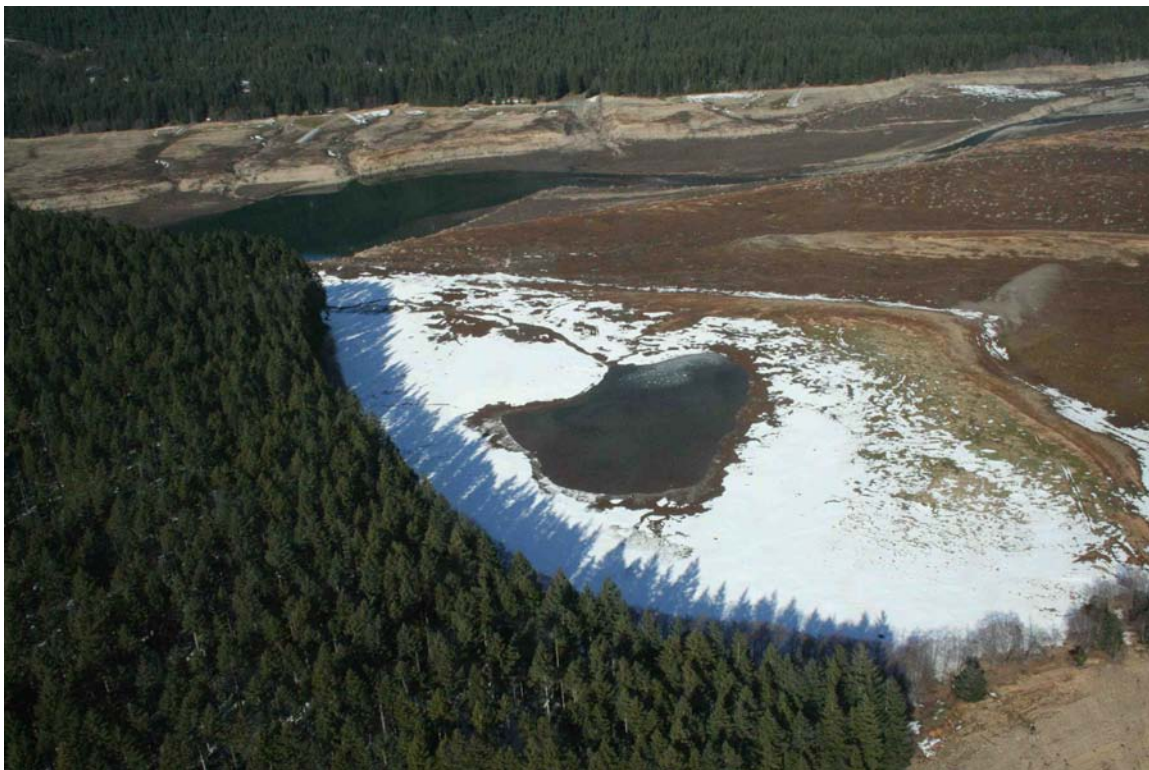
Fig. 8.5.3 - A; Piety Island Campground Waterfront Existing Conditions

Due to the height of this bay, boating access is limited which also results in limited access to the island. Furthermore some of these high spots pose a potential risk for boaters.

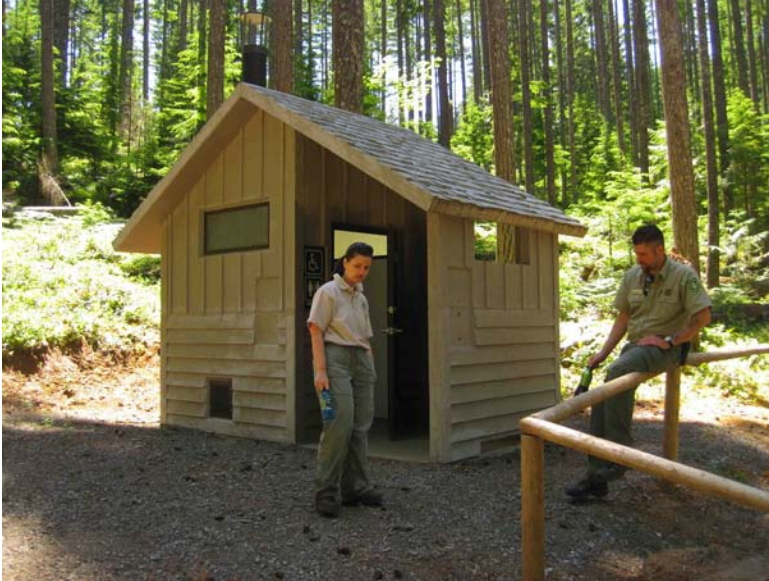
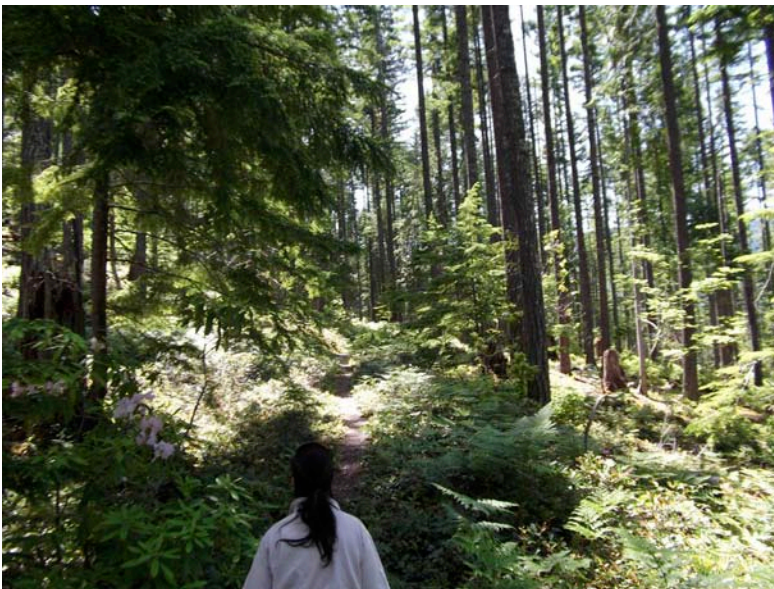
Fig. 8.5.4 - A,B; Piety Island Campground Waterfront Existing Conditions

The trail leading to the summit of Piety Island is not only hard to find but the sign for the trail head is also hard to find until hikers are well on the trail. The trail begins near the restroom facilities, however there is much need for an improvement of wayfinding and imageability at the trail head through signage, plantings, clearing of vegetation or other strategies.

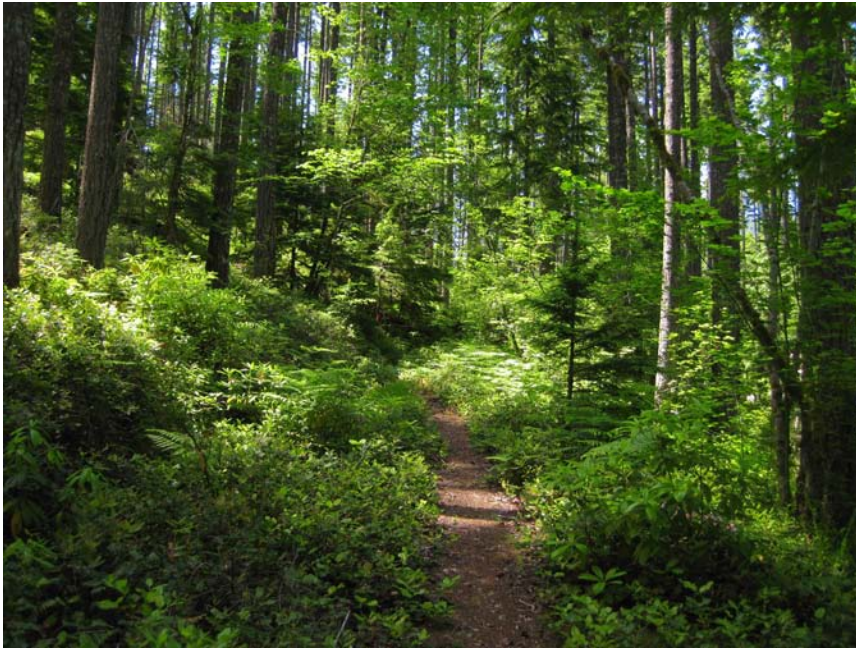
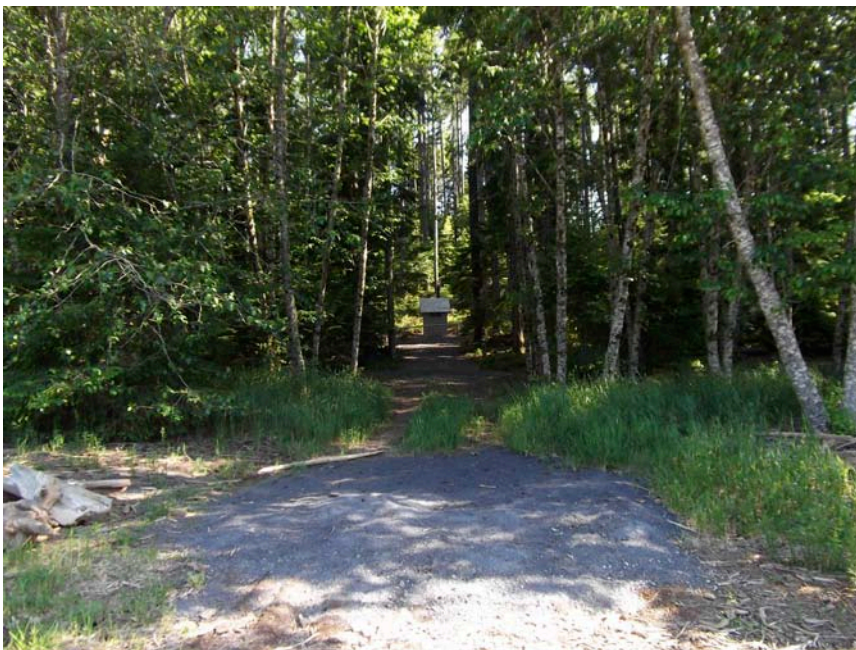
Fig. 8.5.5 - A,B; Piety Island Trails Existing Conditions

The trail leading to the summit of Piety Island follows an old skid road used during the timber harvest on the island. It is wide and easily navigable. There are several clearings along the existing path that were created years ago to open views out over the lake from the island. The pinnacle view of Mount Jefferson is at the summit, framed by tall fir trees. There is also an excellent view of Tumble Falls. This is an experience to be highlighted and promoted for area visitors.

Intended to suit users seeking a primitive experience, these trails are designed to provide a clear route through forest land with minimal annual maintenance. Trails built on steep hillsides are to follow full-bench construction methods, minimizing the risk of failure in wet weather conditions.

The existing trail to the summit of Piety Island needs little improvement. It is usable in its current state. The only improvement recommended here is in the advertisement of the trail. Few area visitors know of the trail without having been to it or having seen it on a map. Maps of the area posted at key locations, such as Kanes Marina, Detroit Flats Day Use Area and within the overnight campground at Piety Island should clearly note this trail and its views as an area attraction.

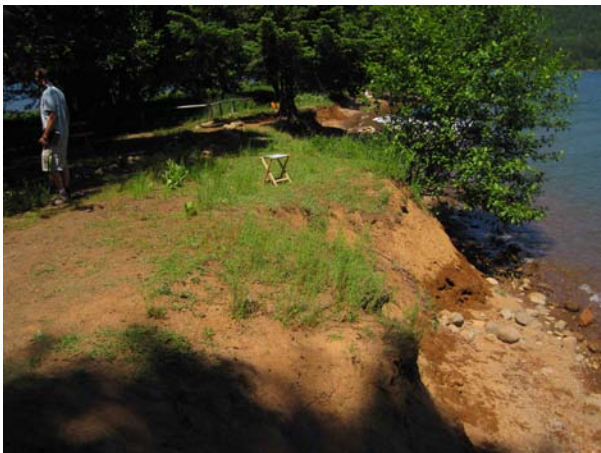
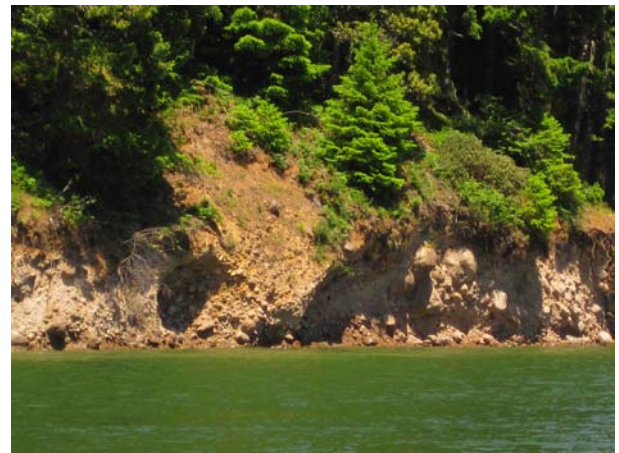
Fig. 8.5.6 - A,B; Piety Island Shoreline Stabilization Existing Conditions

Shorelines at Piety Island are exposed to extreme weather conditions. Strong wave action and high volumes of boaters mooring along the shoreline have accelerated the erosion processes here, particularly along the southeast shoreline, where the banks composed of soft sediment and rounded cobbles are very steep and susceptible to erosion.

For Piety Island, Biotechnical options are highly recommended as the area is seemingly remote and undisturbed to most area visitors and the idea of a "natural getaway" is more compatible with biotechnical approaches, which most aim to blend with the wilderness aesthetic, using natural materials such as living materials to reinforce eroding surfaces.

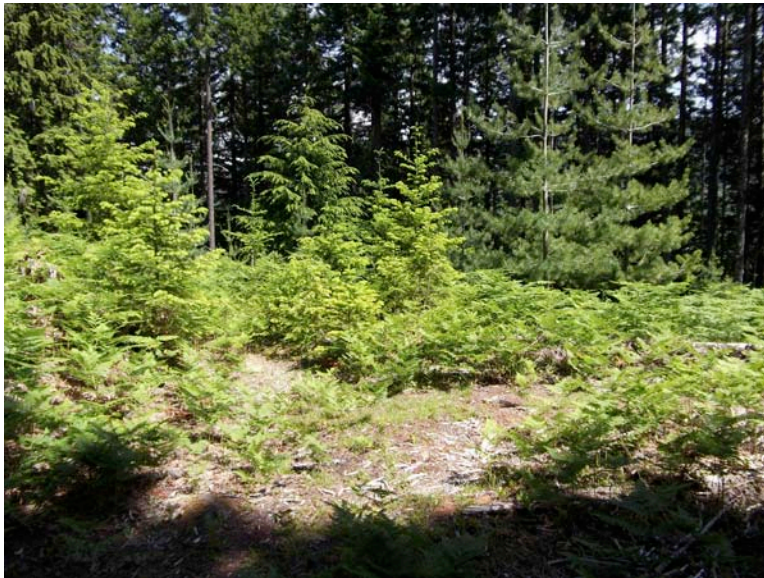
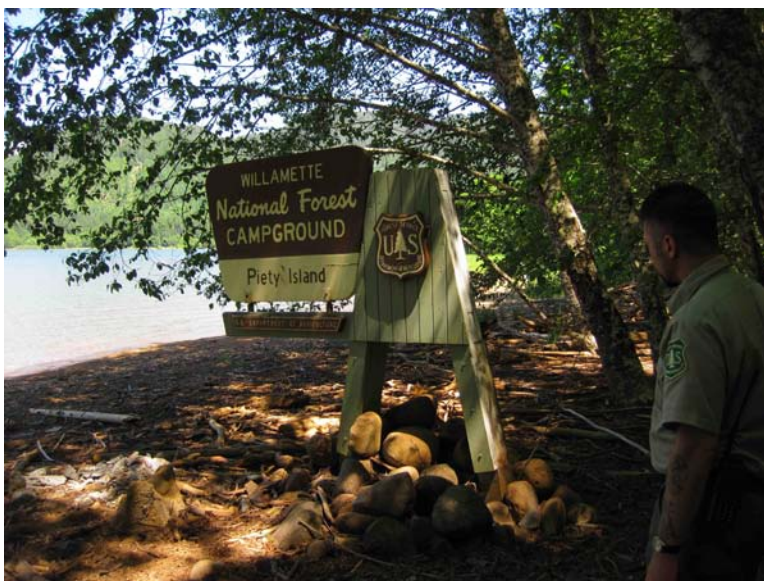
Fig. 8.5.7 - A,B; Piety Island Signage Existing Conditions

Signage is lacking greatly here. There is very little signage to direct visitors to places and very little signage to identify places. Numerous “No Trespassing” signs near property lines create an unwelcoming ambiance. Directional signs leading visitors to designated trails, destinations and points of interest are needed.

In general, signage is greatly needed here for wayfinding and imageability. Existing signs are primarily posted for the purpose of deterring unlawful activities. Additional signs are needed to promote desirable activities, make visitors feel welcome and foster a sense of stewardship for the land.

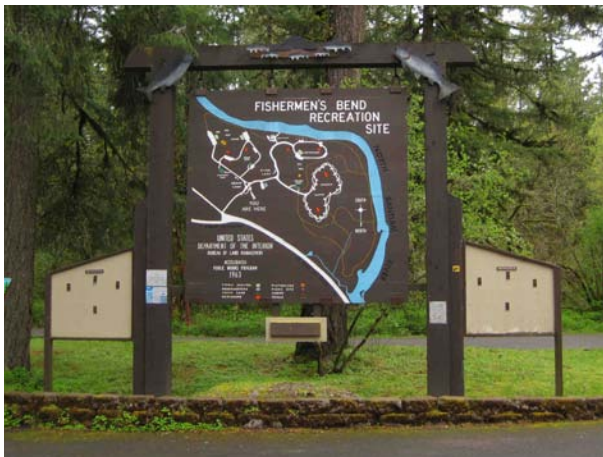
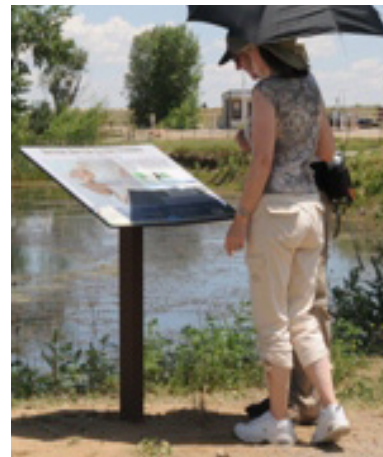
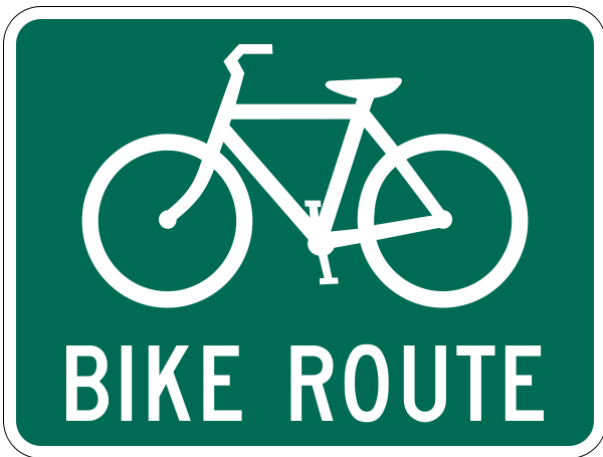
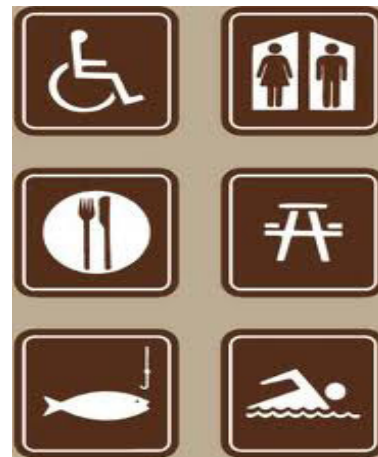
Fig. 8.5.7 - C-G; Piety Island Signage Recommendations

Directional signage guiding visitors to and through the boat mooring areas, loading and day use area is necessary here. A large map of the lake area with key places to visit is needed to inform visitors of recreational opportunities in the area. Other key signs to be included here are: trail head signs, directional signs with distances and times of walking routes, and signs for amenities such as restrooms, trash and recycling facilities.

Directional signs specific to pedestrian traffic include restroom signs, garbage/recycling facilities signs, fishing docks, ADA accessible routes, bike route signs, picnic tables, swimming areas, interpretive signs for natural processes, and restaurants or other business establishments.

Identity signage is also necessary to increase the imageability of Piety Island.

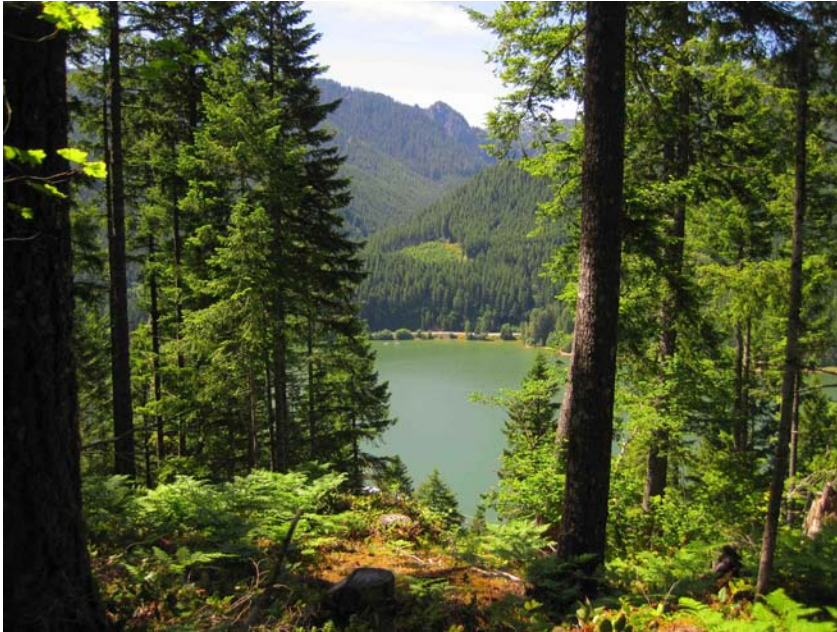
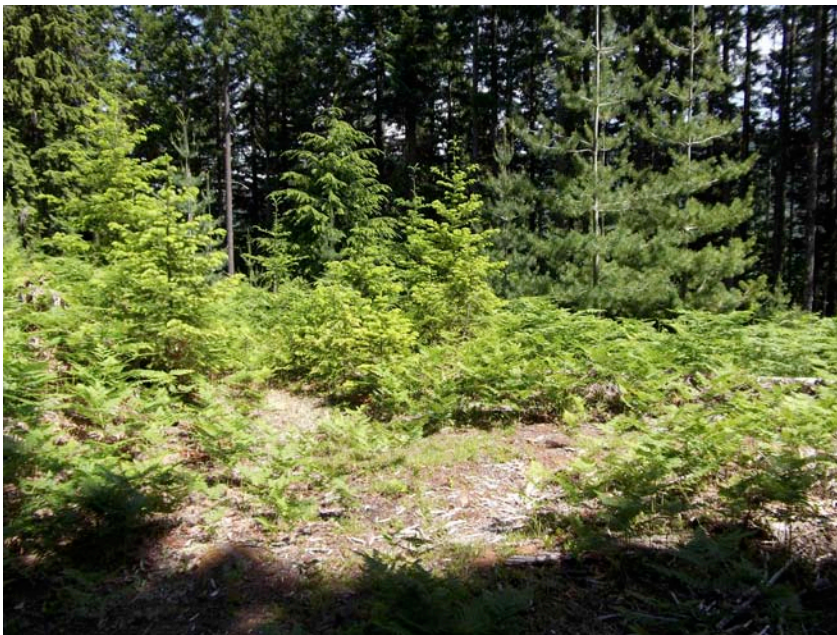
Fig. 8.5.8 - A,B; Piety Island Views Existing Conditions

The top of Piety Island (Piety Knob) has a number of viewpoints that were recently created by timber harvest. These viewing areas or 'windows' provide unique and stunning views of the landscape, including Mt. Jefferson and Tumble Falls. However, these areas are difficult to find as they have not been properly demarcated. Currently there are no signs, maps or other way finding points to bring people to these areas. Furthermore, the trails leading to them are difficult to find and do not clearly read as trails.

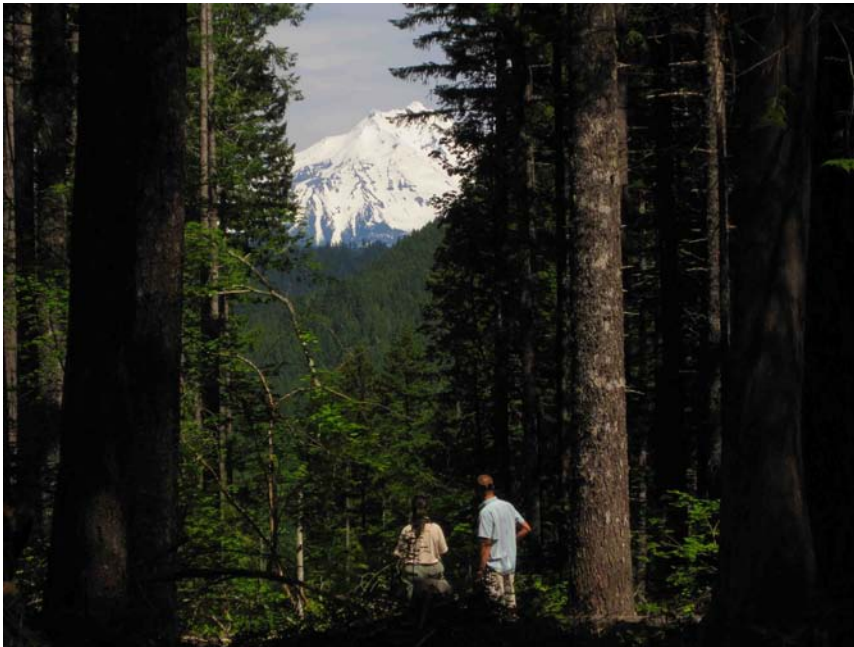
Fig. 8.5.8 - C,D; Piety Island View Recommendations

It is the recommendation of the design that the trails leading to these viewpoints be better demarcated and maintained. Signs and way finding elements should be included at the top of the island as well so that users can find the viewpoints.

Viewpoints should have interpretive signage at each location as well as a seating area or other built structure that clearly defines the space.
