# Detroit Lake Restoration and Enhancement Design Booklet

U.S. Forest Service  
Detroit Ranger District

October 7, 2011

Prepared by: Alex Misar and Lytton Reid

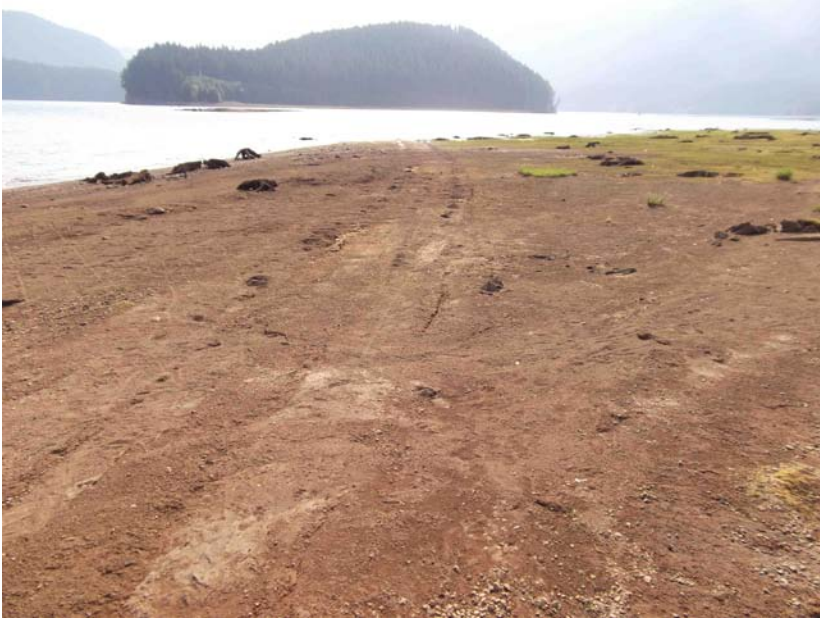
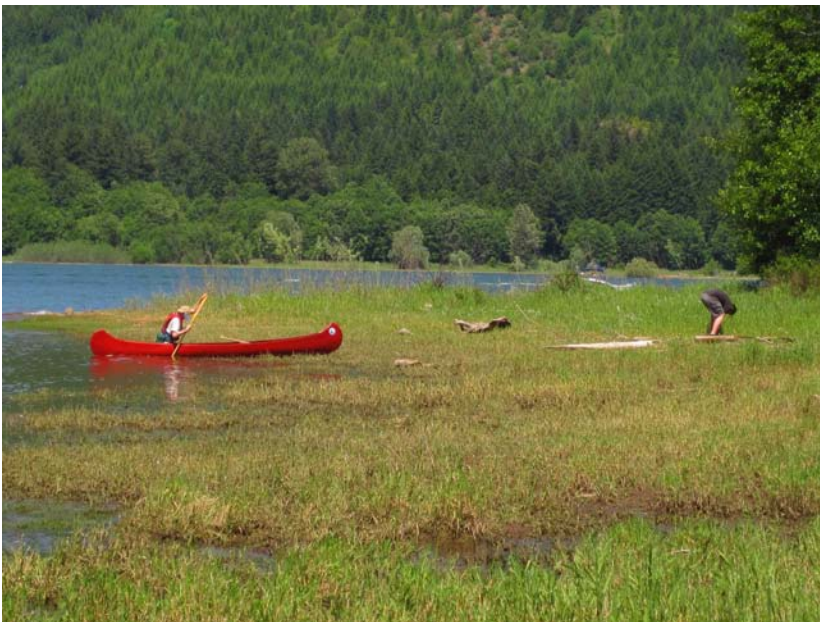
Fig. 8.5.9 - A,B; Piety Island Access Existing Conditions

Access to Piety Island is a limiting factor for recreation and use. During the summer months the island is only accessible by boat and has no formal dock or landing area. During the winter months the island is accessible by foot only by walking across the flats. The Forest Service maintains a winter road to the island for service only. This road is not open to the public.

The design recommends the creation of a dock in the new Piety Island bay for easier boat access and an extended boating season. This dock should be manufactured from durable materials (metal) and should be able to withstand low to no water levels during the winter months. Slope from this dock to the shoreline is an important consideration, as it cannot exceed an 8.3% slope for accessibility reasons.

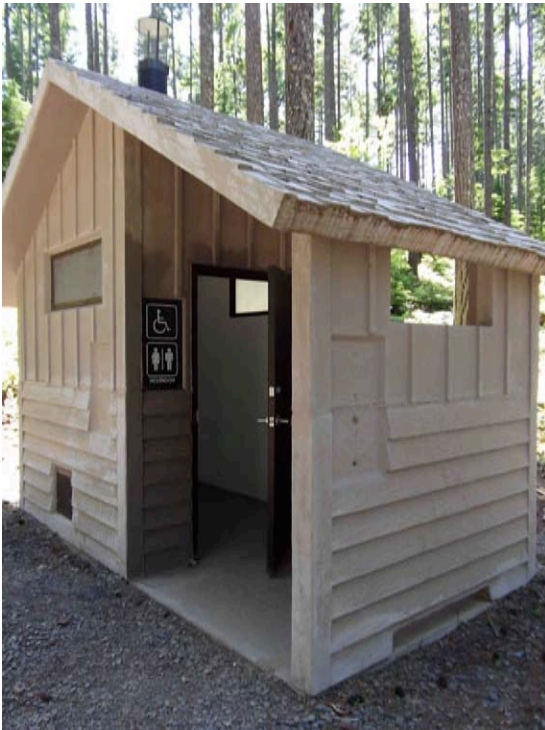
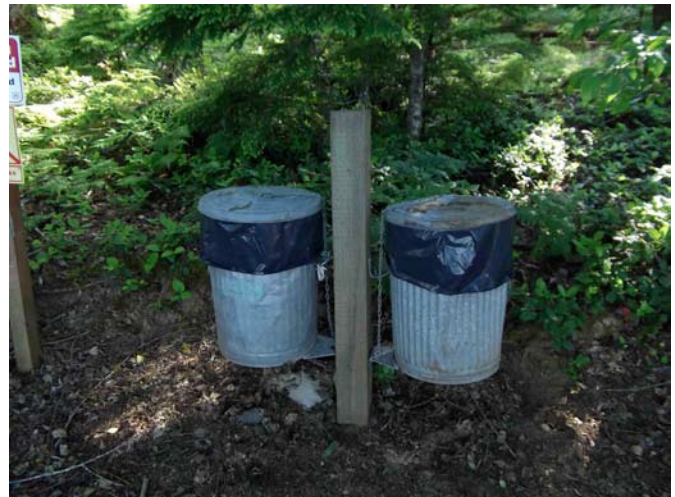
Fig. 8.5.10 - A,B; Piety Island Facilities and Amenities Existing Conditions

Currently, the facilities at Piety Island are limited in both number and quality and need serious improvements to accommodate for both an increased number of users as well as to meet an improved landscape vernacular. Restrooms on site consist of CXT Cascadian style vault toilets. These restrooms function well but cannot accommodate the newly proposed additional campsites on the island. On site trash receptacles are limited and are often full or overflowing from increased use and recycling receptacles of any kind do not exist. Seating consists of picnic benches at each campground which function well, however, the new day use area on the island will need increased seating to accommodate an increased number of people visiting this area. The top of Piety Knob and the 'windows' looking out have no seating or designated viewing area which add to their undefined nature. Fire rings at each campground offer a safe and contained place for users to make a fire. These rings are durable and are generally in good condition.

The design recommends the installment of a new restroom facility on site to accommodate for increased camping and usage. Cascadian vault toilets (currently used here) should be used. The new restroom will be placed on the Northern tip of the camping area. All restrooms must have a 100 foot setback from the water and should sit above the 1569 foot contour. Restrooms should meet the specifications and requirements as outlined in the West Cascades National Scenic Byway Corridor Plan; Detroit Lake Composite Management Guide; The Built Environment Image Guide For National forest and Grasslands; Universal Access Outdoor Recreation: A Design Guide.

New seating has been included in this design so as to accommodate a greater demand. These seats have been placed around the site and should consist of wooden picnic tables like those currently found on site, however, single bench seating is also desirable in select locations. These new seats should be constructed from durable materials (wood) and should aim to match the image requirements outlined in The Built Environment Image Guide For National forest and Grasslands. Specifically, seats at the top of Piety Knob should utilize the 'windows' and face outwards for maximum results.

The design also recommends the addition of new fire rings and picnic tables at each additional campsite.

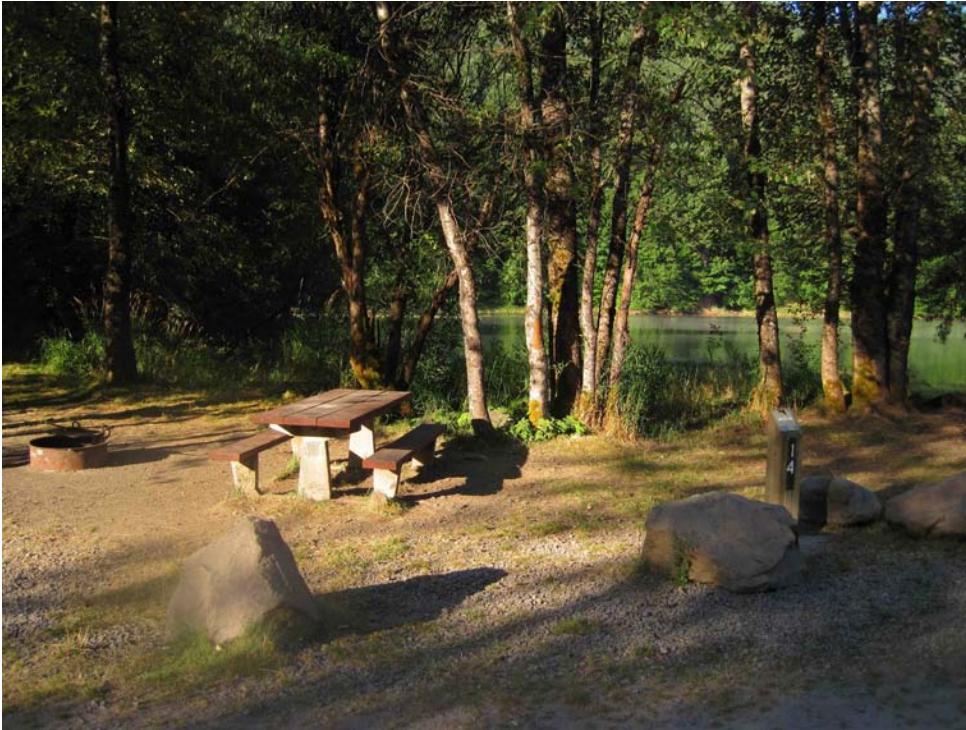
Fig. 9.5.1 - A; Santiam Flats Campsite Existing Conditions

Campsites at Santiam Flats are poorly laid out and require a number of changes. Primarily, the campground layout does not maximize space or efficiently accommodate large numbers of campers. Furthermore, the existing campgrounds have little privacy from one another and are poorly defined both in location and site to site.

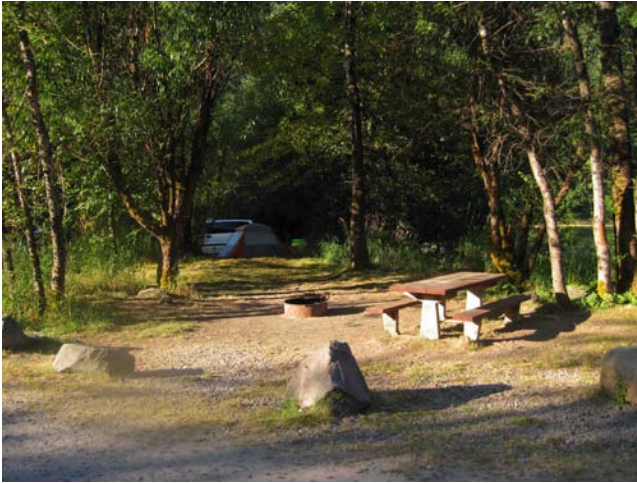
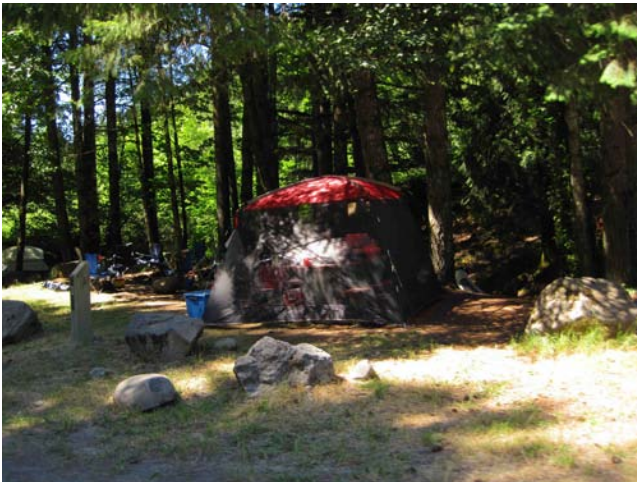
Fig. 9.5.2 - A,B; Santiam Flats Campsite Privacy Existing Conditions

Due to their layout and low numbers of surrounding vegetation the current campgrounds at Santiam Flats have little privacy and feel exposed. Views into adjoining campsites diminish the privacy and intimacy of the camping experience as well as create a feeling of uncomfortableness and vulnerability. Furthermore, the want for nature and a natural camping experience cannot be appropriately achieved given this camping style.

It is the recommendation of the design to increase vegetation between and around campsites so as to block views in and out of campsites. This increase in vegetation will help to maximize privacy as well as create a more natural aesthetic.

These vegetative screens should utilize plants of a medium height (4-10') with a dense growth that are native and tolerant of site specific conditions (See Appendix). Plants should also be chosen on their resilience to human use (ex. firewood, marshmallow sticks, etc.). Establishing these plants will take time and will require protection to ensure their survival during the first year or two. Temporary wood structures can be placed at the edge of campsites to deter trampling of these new plants during this time.

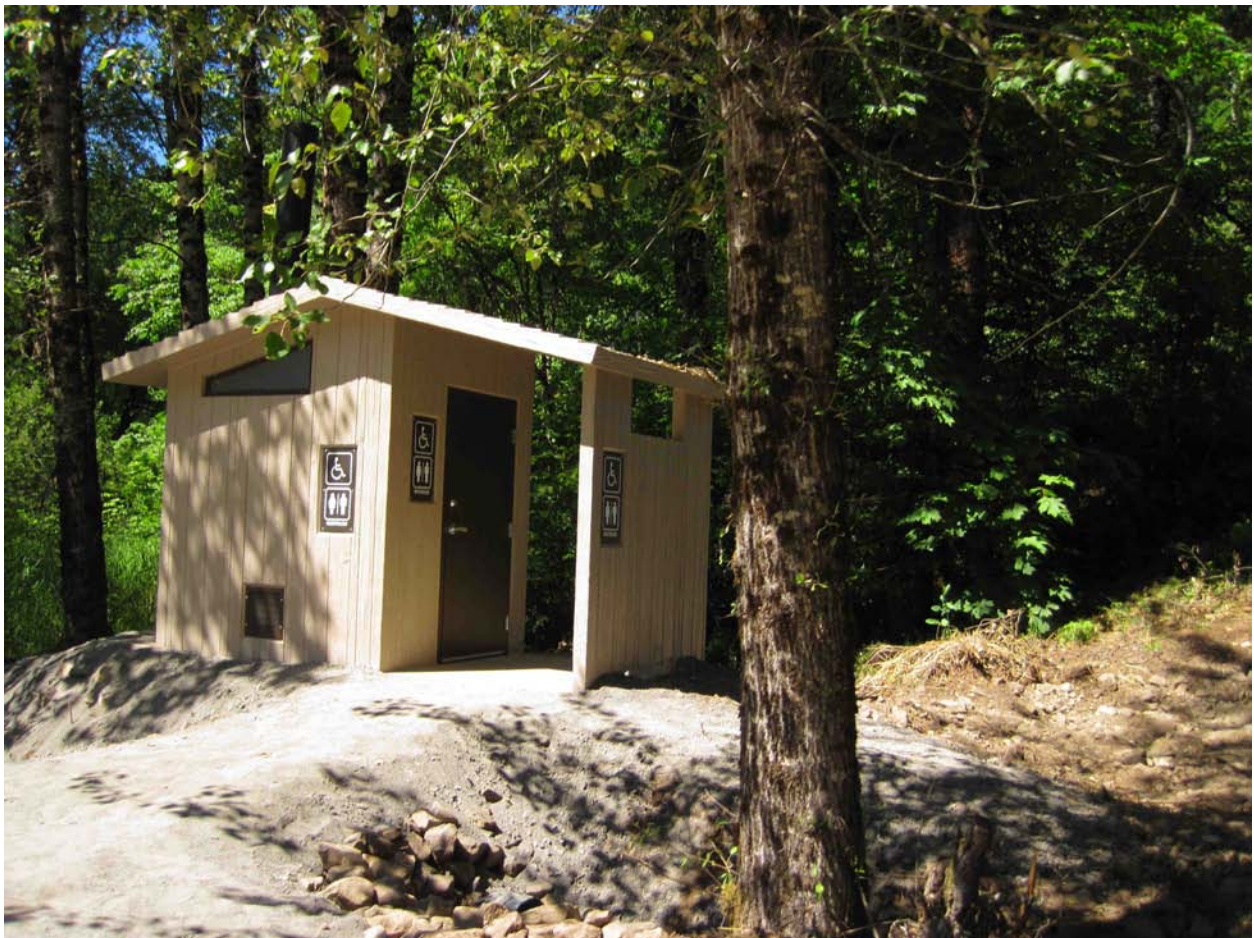
Fig. 9.5.3 - A; Santiam Flats Facilities and Amenities Existing Conditions

Currently, the facilities at Santiam Flats are limited in both number and quality and need serious improvements to accommodate for both an increased number of users as well as to meet an improved landscape vernacular. Restrooms on site consist of CXT Cascadian style vault toilets. These restrooms function well but cannot accommodate the newly proposed additional campsites at the site. On site trash receptacles are limited and are often full or overflowing from increased use and recycling receptacles of any kind do not exist. Seating consists of picnic benches at each campground which function well, however, the new day use area on the island will need increased seating to accommodate an increased number of people visiting this area. Fire rings at each campground offer a safe and contained place for users to make a fire. These rings are durable and are generally in good condition.

The design recommends moving, or replacing, the existing CXT toilets on site to match the new design. As the site is connected to the city of Idanha's water system one possibility is to connect new restroom facilities to the municipal water system. However, where this is not appropriate the current CXT toilets can adequately accommodate demands. These restrooms must have a 100 foot setback from the water and should sit above the 1569 foot contour. New restrooms should meet the specifications and requirements as outlined in the West Cascades National Scenic Byway Corridor Plan; Detroit Lake Composite Management Guide; The Built Environment Image Guide For National forest and Grasslands; Universal Access Outdoor Recreation: A Design Guide.

New seating has been included in this design so as to accommodate a greater demand. These seats have been placed around the site and should consist of wooden picnic tables like those currently found on site, however, single bench seating is also desirable in select locations. These new seats should be constructed from durable materials (wood) and should aim to match the image requirements outlined in The Built Environment Image Guide For National forest and Grasslands.

The design also recommends the addition of new fire rings at each additional campsite including the R.V. and yurt areas, respectively.

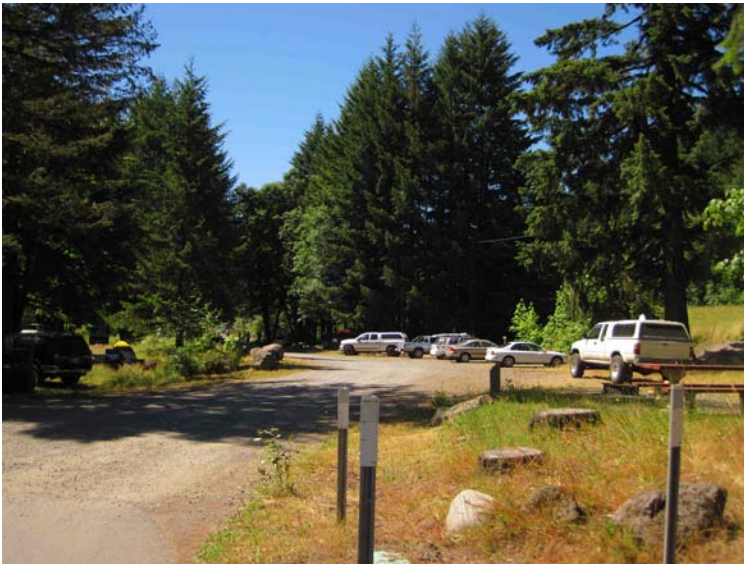
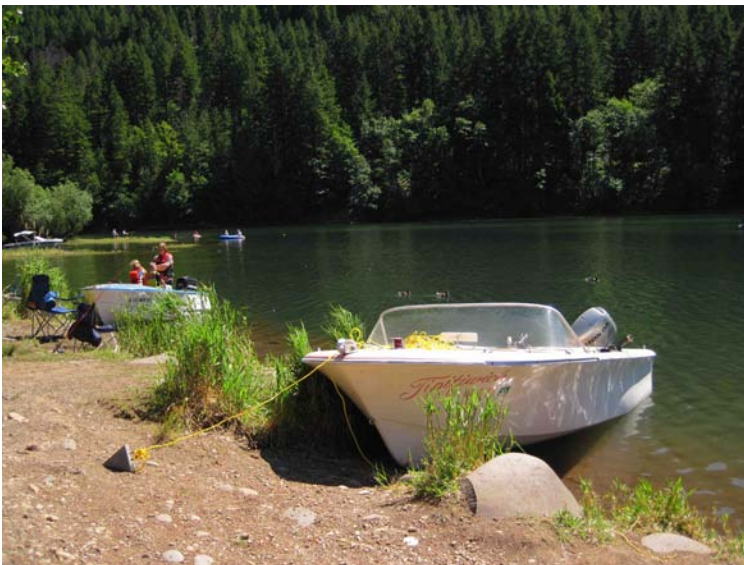
Fig. 9.5.4 - A,B; Santiam Flats Access Existing Conditions

The overall access to the Santiam Flats area is good with the exception of a few key areas. The primary access point to the day use area is off of highway 22, which, despite the lack of signage (see Pg. 108) provides easy access to the site. Access through the site is limited to the primary vehicle road through the site. This gravel road requires frequent maintenance and is the cause for increased dust in the site.

Furthermore, Santiam Flats does not provide universal access or accommodate in any way disabled users.

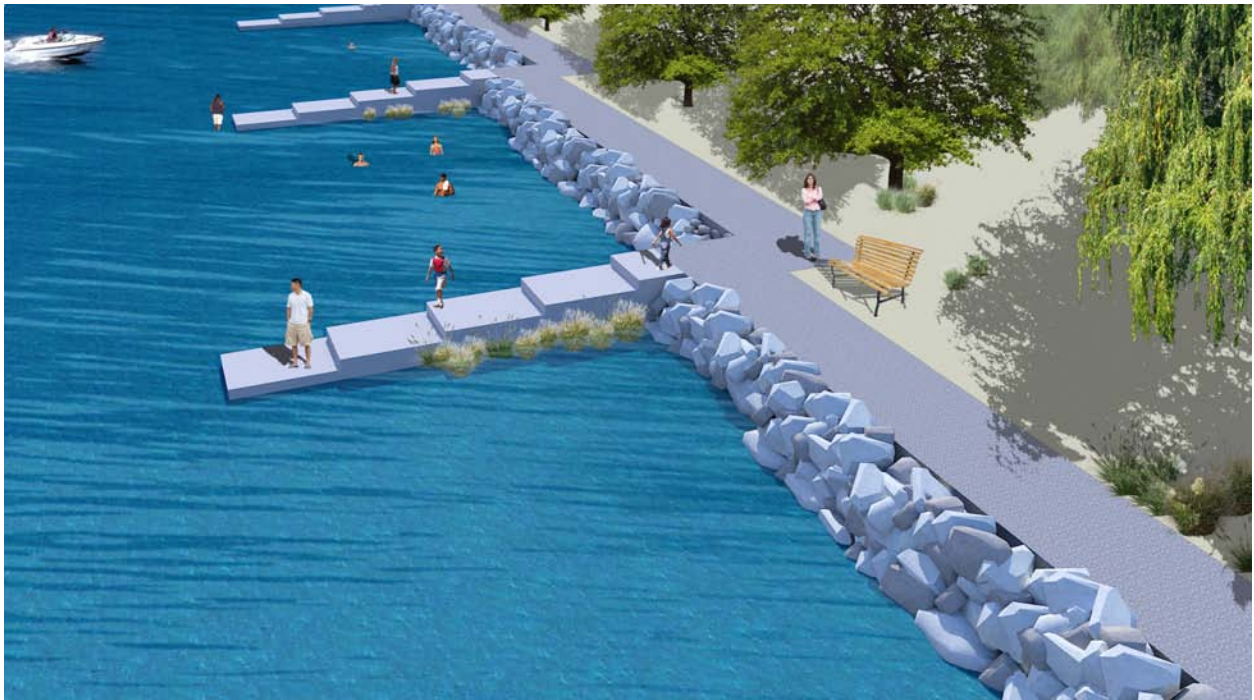
Fig. 9.5.4 - C; Santiam Flats Access

To increase accessibility in this area the design recommends the installation of a number of new trails. These trails should be constructed from asphalt and be fully ADA accessible. New trail heads, signs and way finding elements should be employed throughout the site to designate areas and access points.

The design also recommends replacing the existing gravel road with a new asphalt road. This road will not only require less maintenance than the existing gravel road, it will provide universal access throughout the site.

Access to the water will be greatly improved by the addition of a new day use area with armored shorelines (see Pg. 104), fishing areas (see Pg. 110), and universal water access.

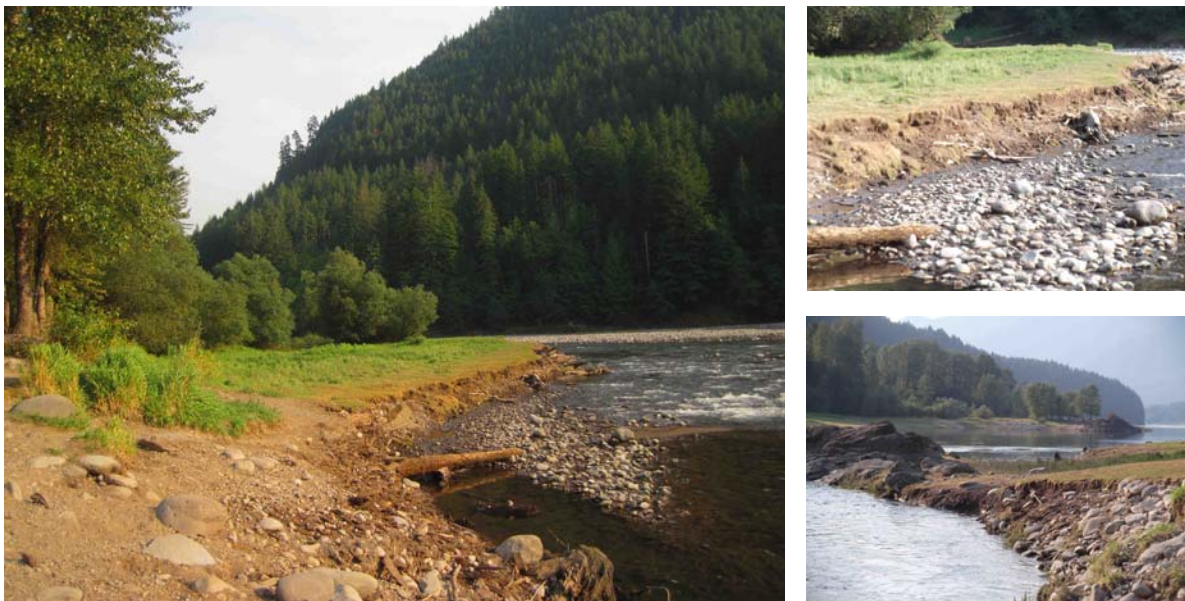
Fig. 9.5.5 - A,B,C; Santiam Flats Shoreline Erosion Existing Conditions

Erosion processes are a natural part of the hydrologic cycle and provide essential habitat for plants, fish and wildlife as well as ecosystem services such as water filtration and soil formation. Erosion of Detroit Lake's 32 miles of shoreline however is arguably unnatural, as it is a product of the man-made Detroit Dam, built in 1953 to control flooding.

Erosion is most extreme at elevations near the normal pool water level of 1,563.5 feet above sea level during the summer season when strong wind waves and boat wakes breakdown the softer sedimentary layers of the steep banks. For six months of the year, from mid-April until mid-September, the water level is typically between 1,554 feet and 1,566 feet (though levels could be as low as 1,542 feet during the popular boating season in years of drought). This section of the shoreline is in critical need of stabilization because it undergoes the most damage in a very short period of time.

Recommended shoreline stability treatments include all four general approaches to shoreline stabilization as potentially successful remedies.

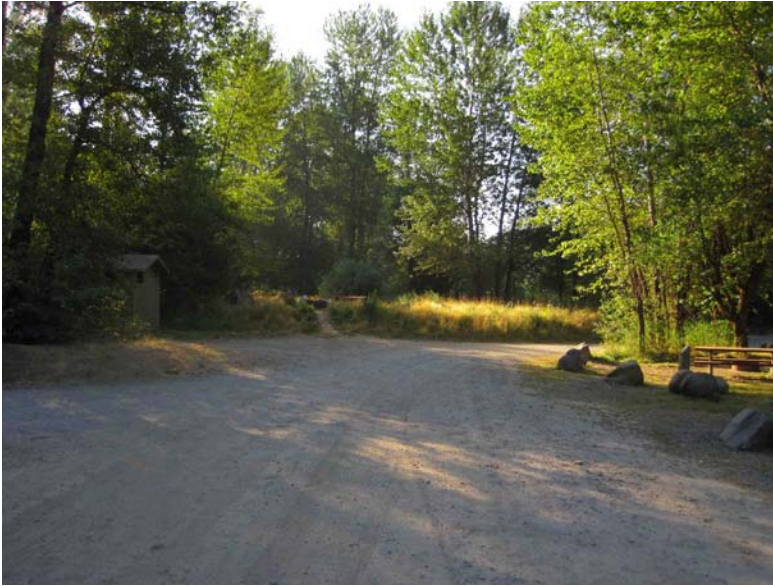
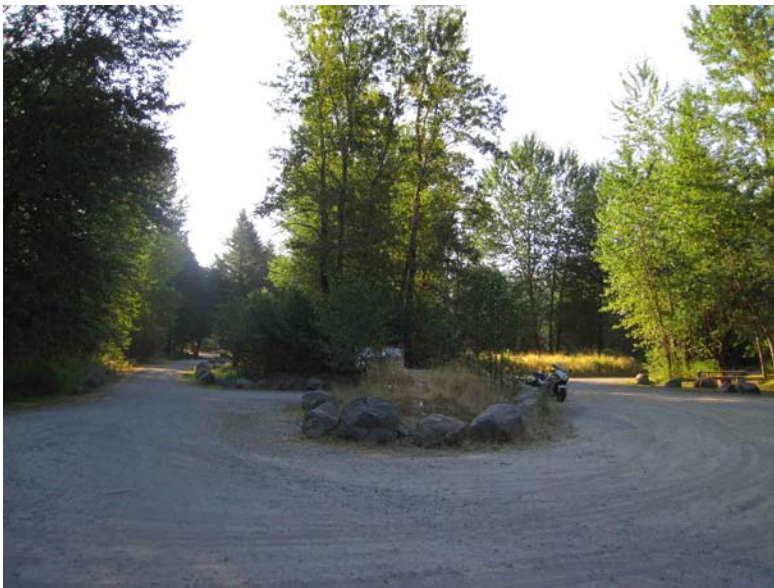
Fig. 9.5.6 - A,B; Santiam Flats Roads Existing Conditions

The current road in the Santiam Flats area, while functional, could use improvements. Currently, this road is asphalted until the campground starts at which point it switches to compacted gravel. This gravel creates dust in the summertime and requires yearly maintenance. Furthermore, it is not universally accessible and would ultimately need to be replaced to match the new design of the campground.

The entirety of the campground road should be asphalted and systems employed to mitigate storm water from runoff. These systems could include bioswales, flow through planters, or wetland mitigation. Connections to the new parking lots should be taken into account when designing these roads. New roads will be created in the campsite per the design.

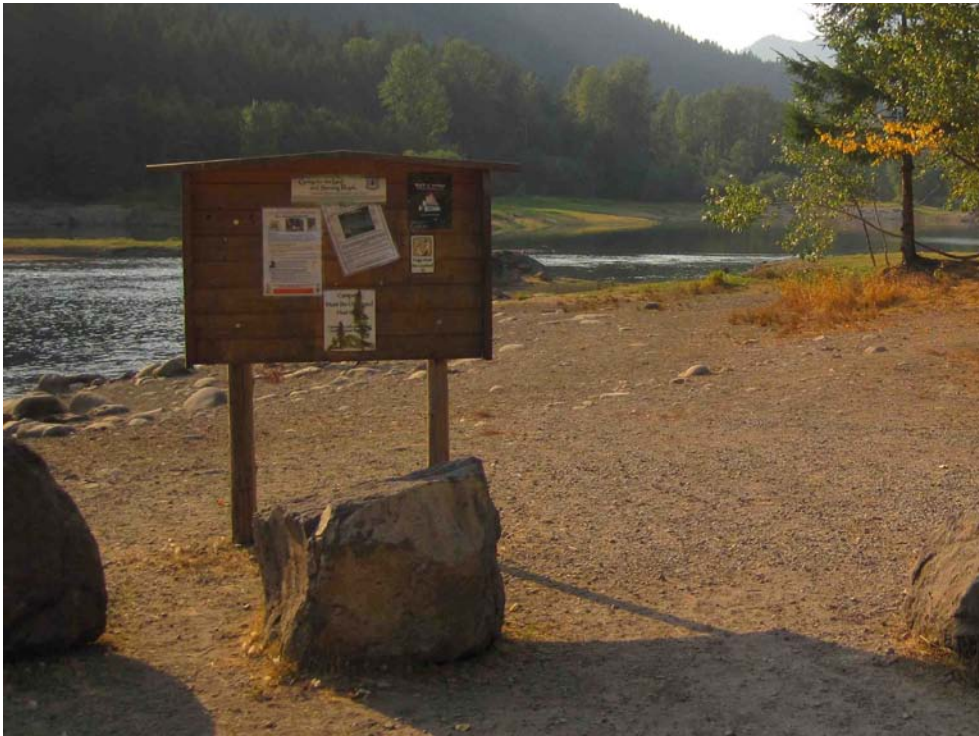
Fig. 9.5.7 - A; Santiam Flats Signage Existing Conditions

Signage is lacking greatly here. There is very little signage to direct visitors to places and very little signage to identify places. Directional signs leading visitors to designated trails, destinations and points of interest are needed.

In general, signage is greatly needed here for way finding and imageability. Existing signs are primarily posted for the purpose of deterring unlawful activities. Additional signs are needed to promote desirable activities, make visitors feel welcome and foster a sense of stewardship for the land.

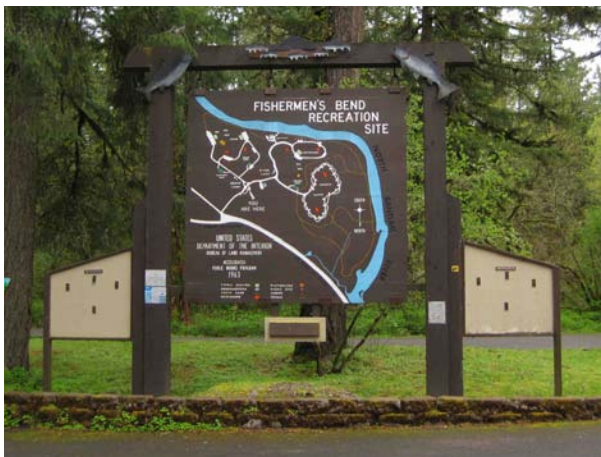
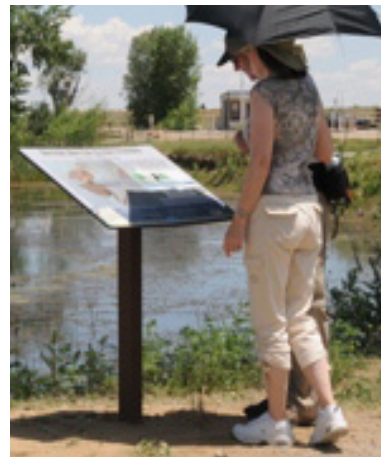
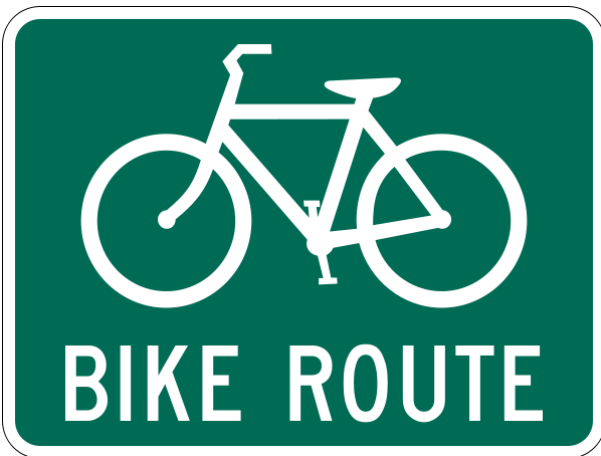
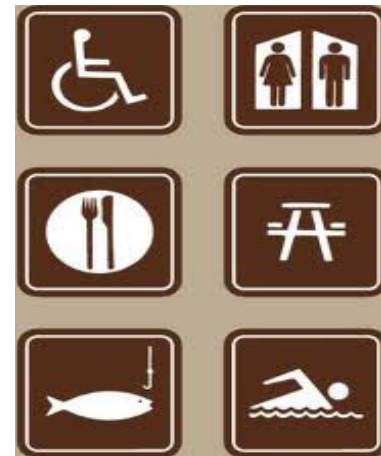
Fig. 9.5.7 - B-E; Santiam Flats Signage Recommendations

Directional signs specific to pedestrian traffic include restroom signs, garbage/recycling facilities signs, fishing docks, ADA accessible routes, bike route signs, picnic tables, swimming areas, interpretive signs for natural processes, and restaurants or other business establishments.

Identity signage is also necessary to increase the imageability of Santiam Flats. A gateway, welcome or threshold sign letting visitors know they have arrived is valuable to the imageability of the area.

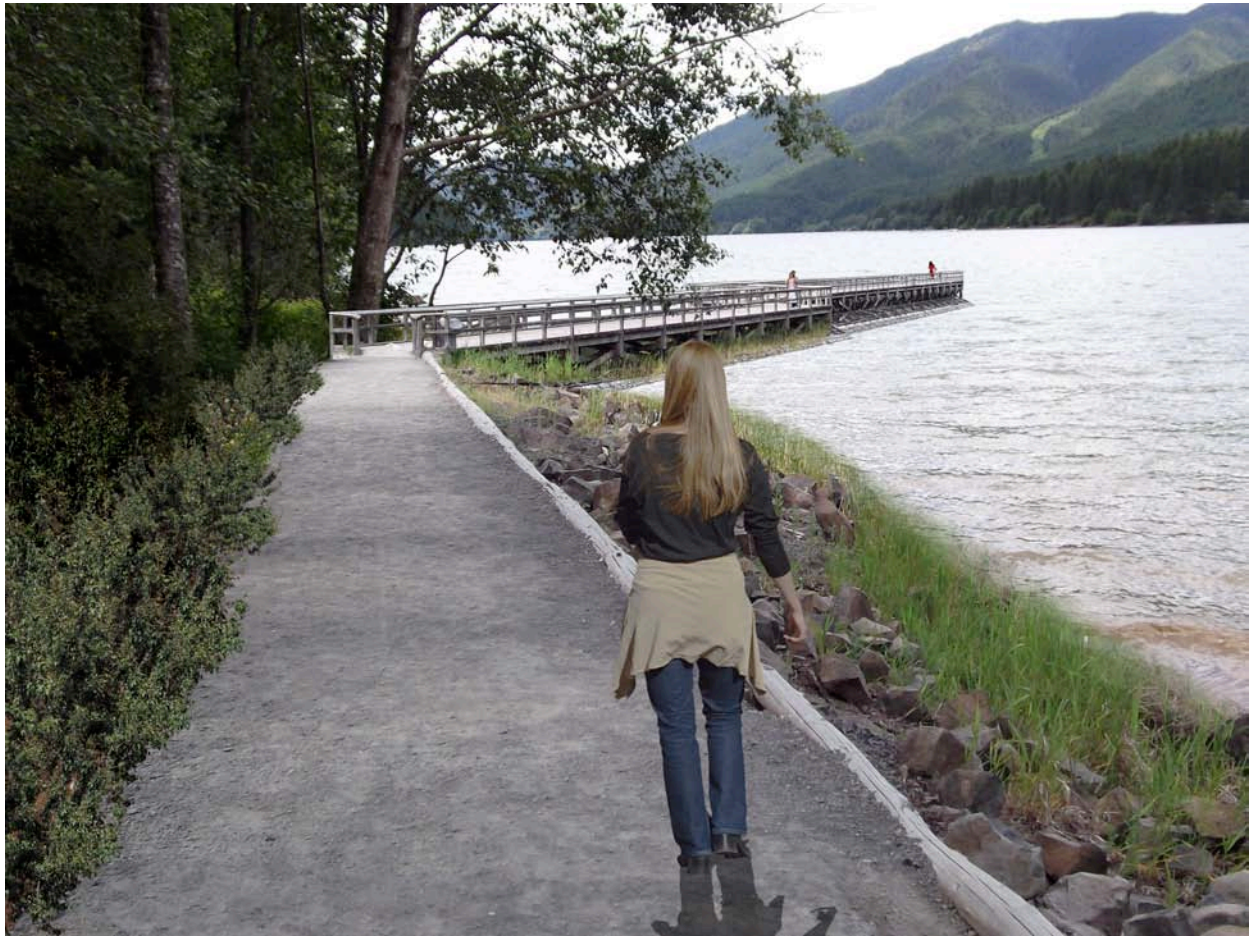
Fig. 9.5.8 - A; Fishing Platform

There is a current demand in the Detroit Lake area for more fishing areas and ADA accessible fishing platforms. Although attempts have been made in other areas there is still a demand for more accessible fishing areas. Similarly, Santiam Flats has a large demand for more fishing that has not been met.

In an effort to meet these demands a number of fishing piers have been included in the redesign of the Santiam Flats area. The design recommends two options to meet this demand. The first of these designs employs fishing piers constructed from wood and similar in style to the one at Hoover Campground. Most likely, new soil will be needed to help keep these structures in place, however, this soil can come from any number of the proposed dredging projects at Kanes, Piety Island or Detroit Flats.

The second option employs a terraced system of steps and ramps that allows patrons to walk to the waters edge regardless of the height of the lake. This terraced system would be constructed from concrete and would need to conform to ADA specifications.

The length of these piers still needs to be determined and will be based in part on the existing topography at the sites.

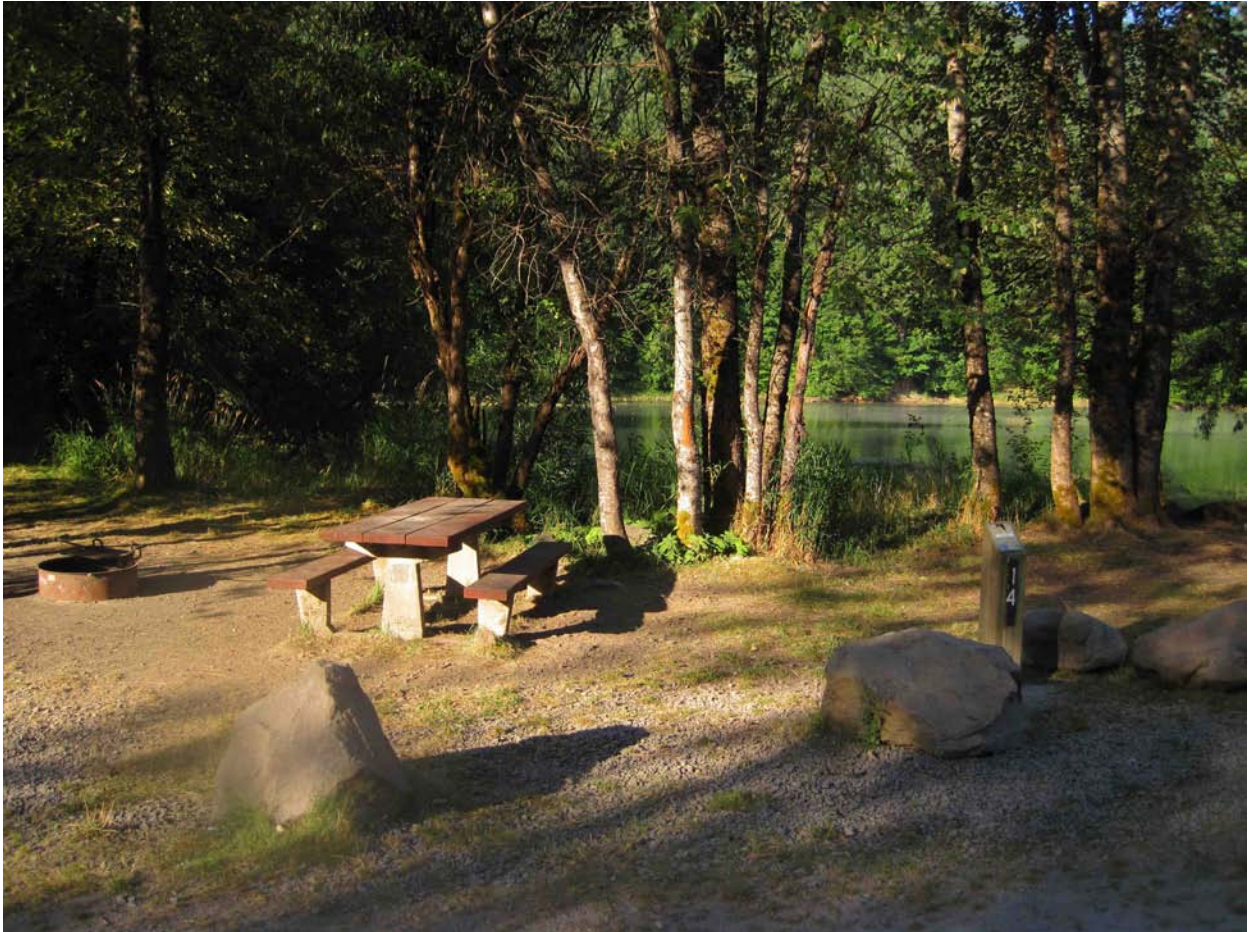
Fig. 9.5.9 - A; Santiam Flats Existing Conditions (Without Yurts)

Currently, Santiam Flats only provides camping opportunities to tent and RV users. In an effort to expand the recreational and camping opportunities on the site the design recommends the construction of 8 yurts.

These yurts could be installed one at a time as funding becomes available and could utilize other camping sites if demand were strong. Furthermore, the yurts could generate profit which could be used to buy new ones. Architecturally the yurts should conform to ADA guidelines as well as Forest Service design guidelines that are consistent with the Cascadian Style.

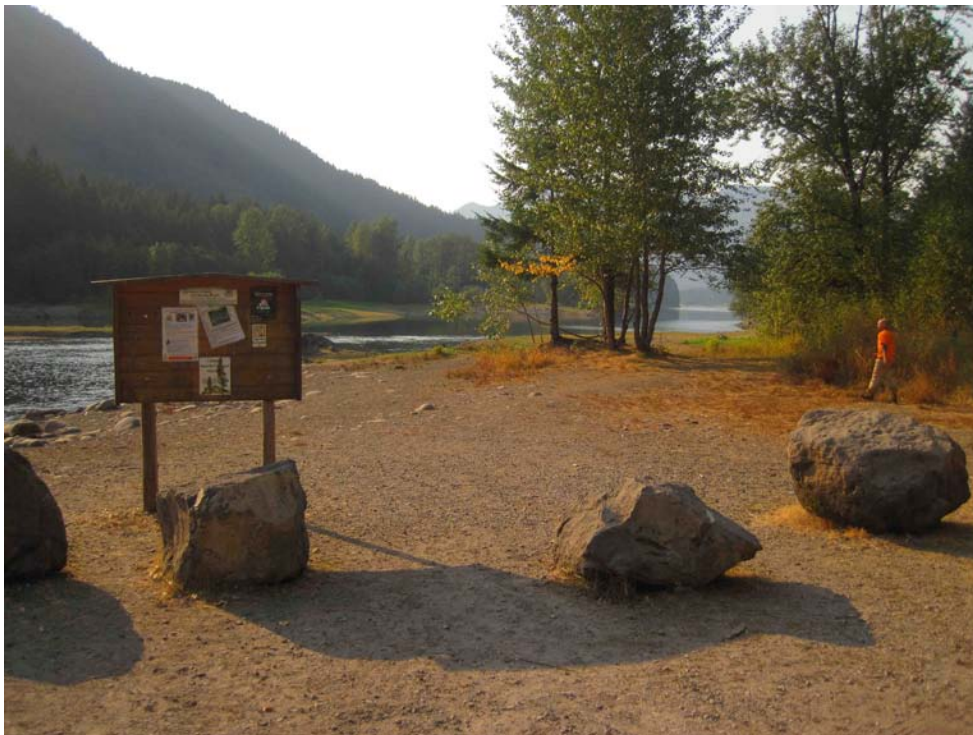
Fig. 9.5.10 - A; Santiam Flats Day Use Existing Conditions

The day use area at Santiam Flats is undefined and lacks recreational opportunities. Fishing and swimming are the two main activities here, however, the day use area has limited room to accommodate the demand and use. There are no tables or seating areas here in the day use area and users are forced to sit on the ground or occupy an adjacent camping site. A small parking area directly adjacent to the day use area is commonly used despite no parking signs.

The design recommends the creation of a better defined day use area at the Western tip of the site. This day use area will be replete with seating (see Pg. 100), fishing piers (see Pg. 110), universal water access and a new covered structure (see Pg. 114).

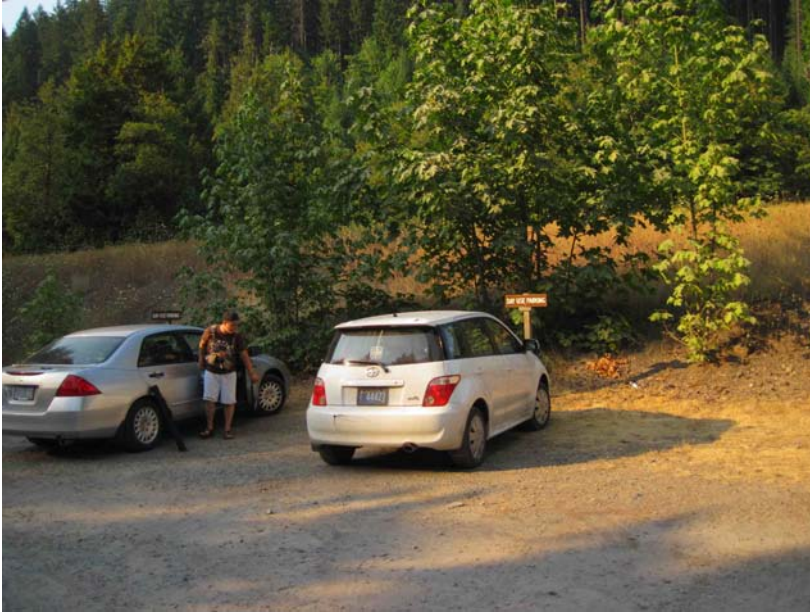
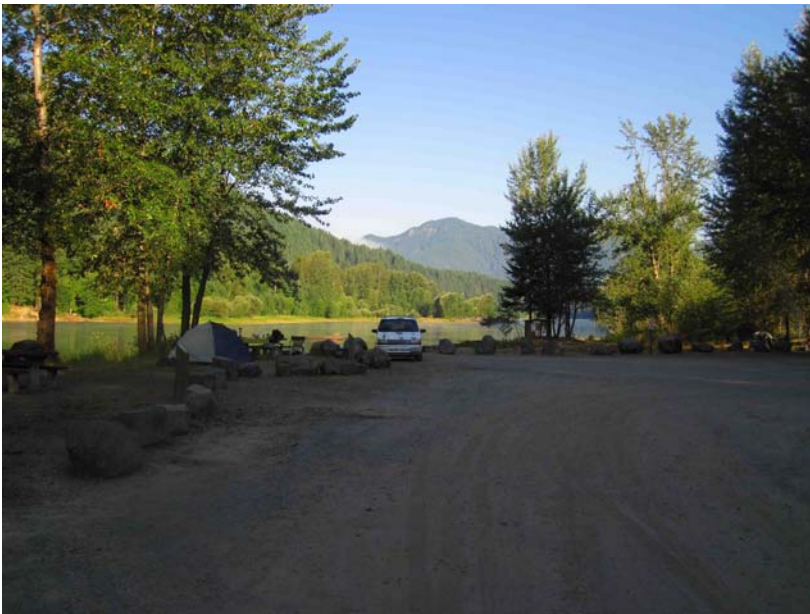
Fig. 9.5.11 - A,B; Santiam Flats Parking Existing Conditions

Current parking at Santiam Flats consists of individual campsite parking and a small day use area on the East side of the site. These areas are compacted gravel and only provide parking to a limited number of vehicles. They are not wheelchair accessible and cannot provide universal access.

The design recommends asphaltting the primary road in Santiam Flats and with that the individual campground parking sites as well. New RV camping areas have been designated on the Northern side of the site and will require asphaltting as well. These RV sites require a parking area of 25 x 50' to accommodate for the different number of campers that will occupy the space.
